**Figure 1** Scanning electron micrographs of the five limestones

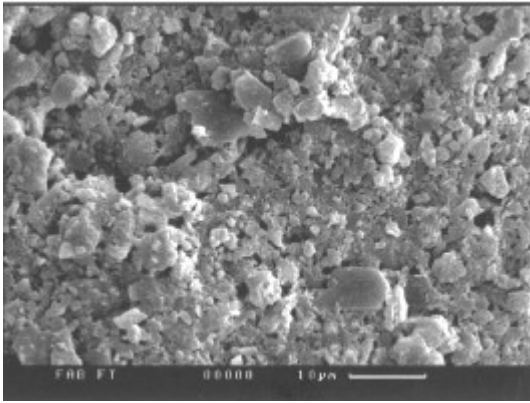
(a) Sparry limestone (SpaL)

High magnification micrograph showing densely interlocking grains with increased porosity in association with fossils. There is also some alignment of pores.

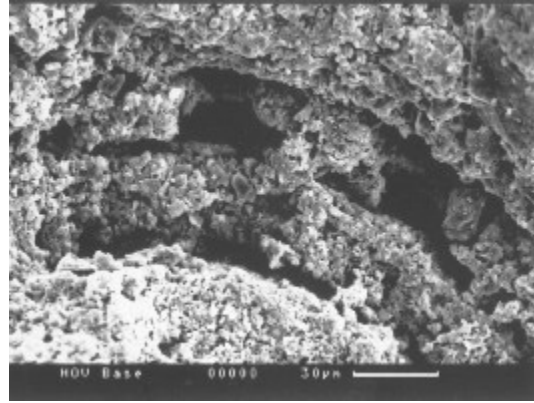
(b) Oolitic limestone (OoL)

Concentric ooid layers showing the contrast between inter and intra-layer porosity.

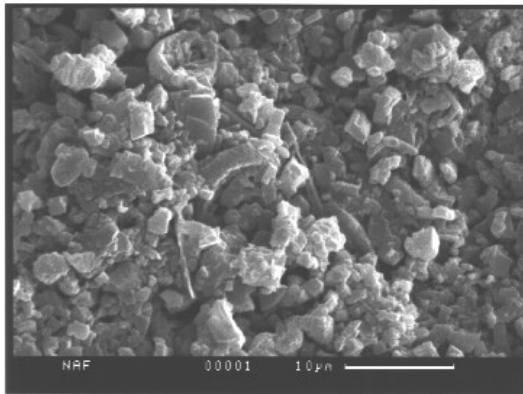
(c) High density chalk (HdCh)

Coccoliths and fine matrix. With the exception of macropores associated with fossils, there is a narrow distribution of pore sizes concentrated in the range 0.5 to 2 micrometers.

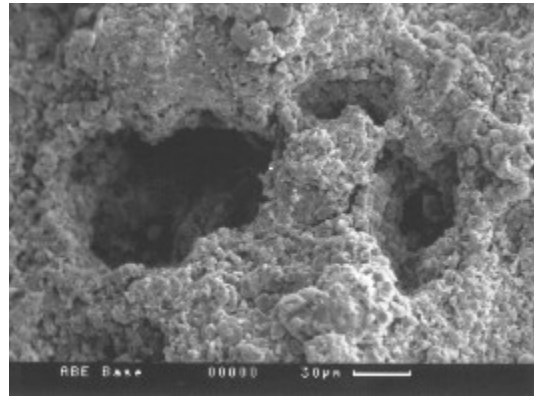
(d) Magnesian limestone (MagL)

Typical sub-rounded macropores. These usually have very narrow connections to other pores, often with narrow, irregular microcracks around their circumference.

(f) MagL: Post salt weathering  
Low magnification view showing coarse pores. The relief of many of these pores is much more subdued than was typical prior to testing (compare with Figure 1d).

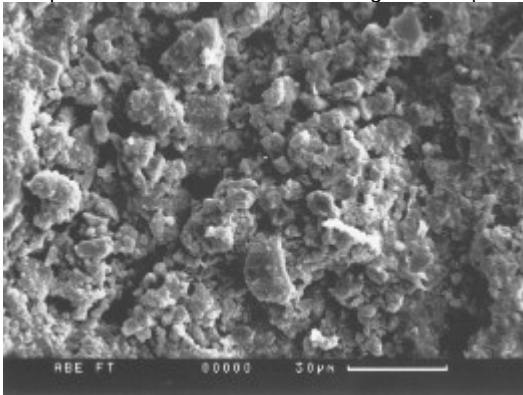
(e) Magnesian limestone (MagL)

A similar magnification view of MagL to (d) showing an area with much finer and more angular pores, with macropores being absent.

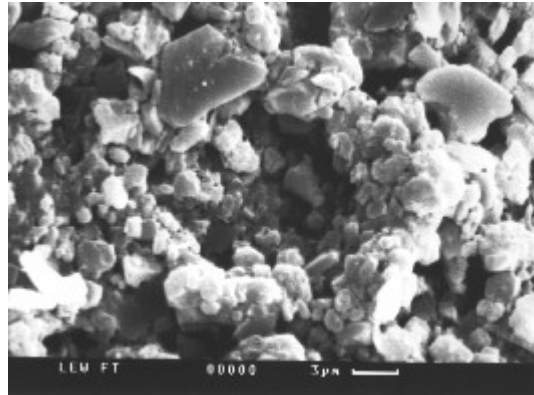
(f) Low density limestone (LdCh)

Round, 10 micrometer pores formed by spar-lines foraminifera tests. The whole rock structure is very loose and porous.

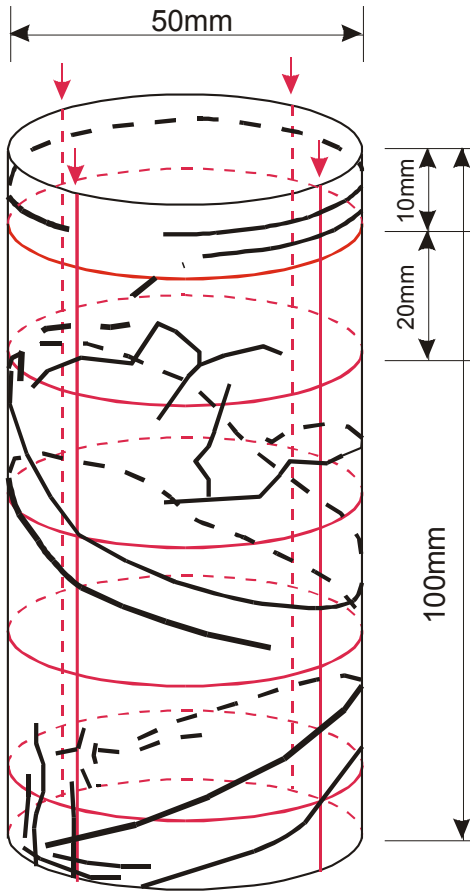
**Figure 2** Schematic representation of fracture density measuring grid superimposed on a standard cylindrical specimen.

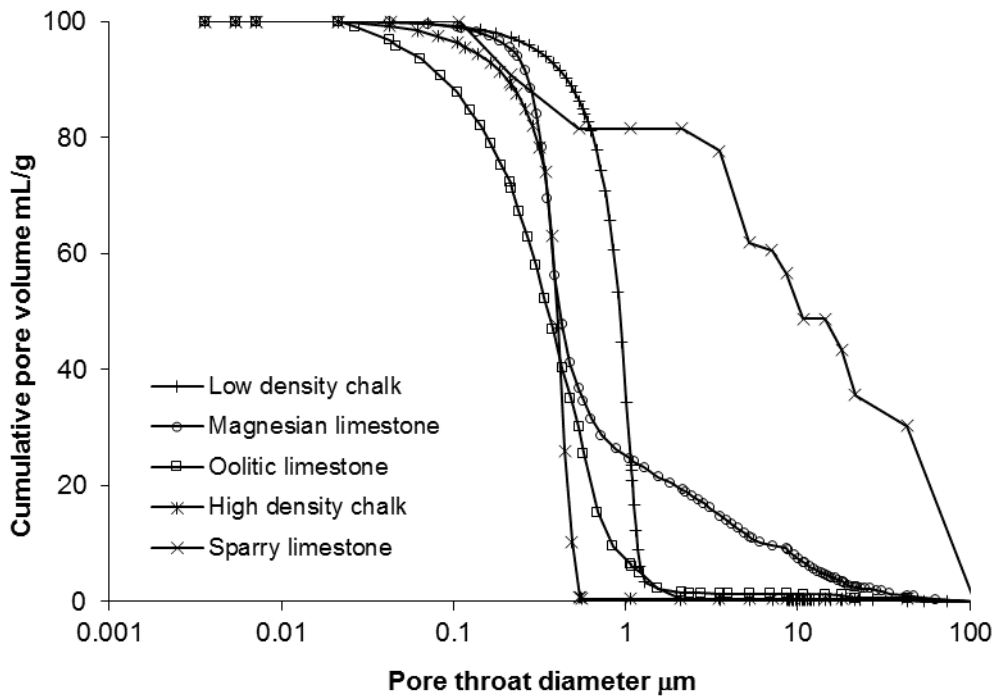
**Figure 3** Pre-test pore size distributions for the limestones tested

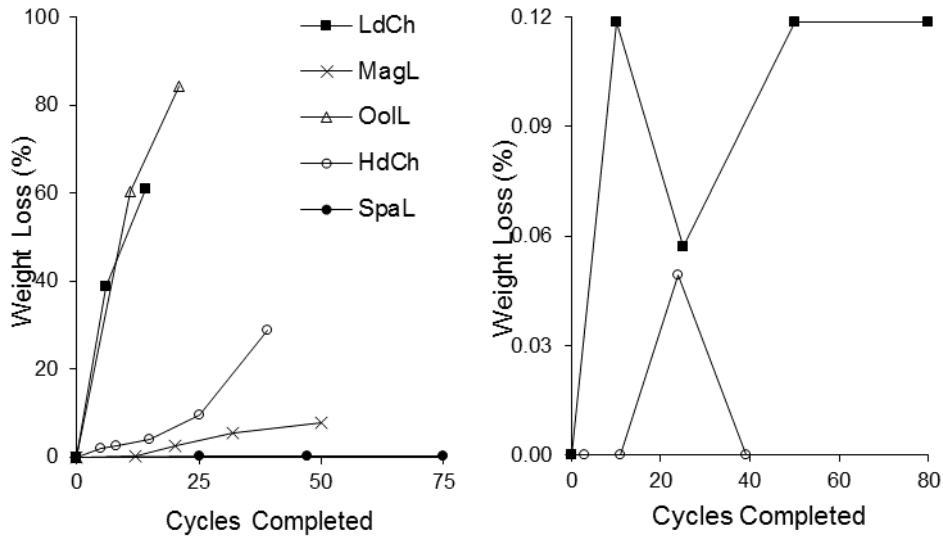
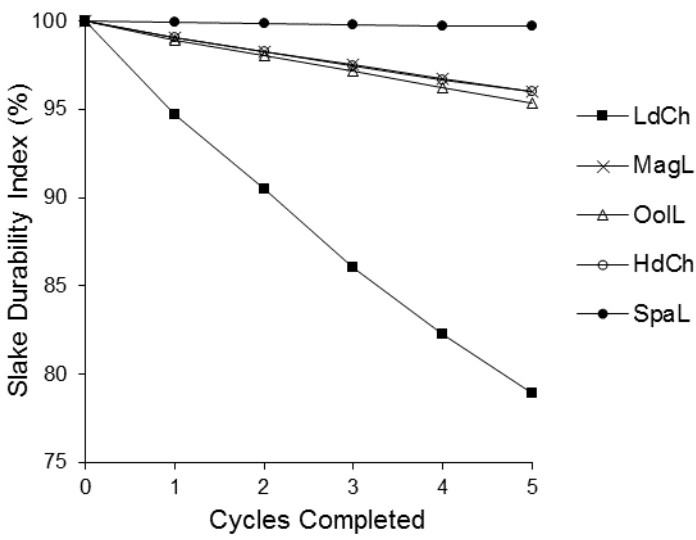
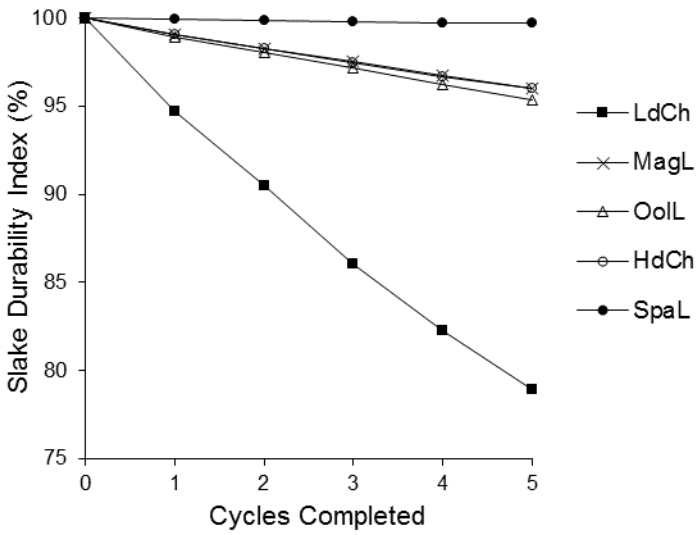
Figure 4a–d Weight loss due to experimental weathering of five limestones

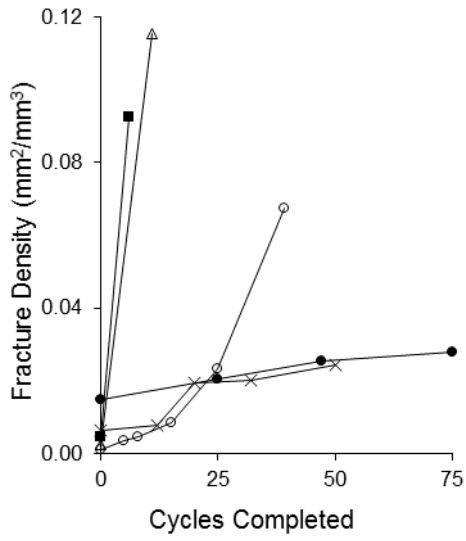
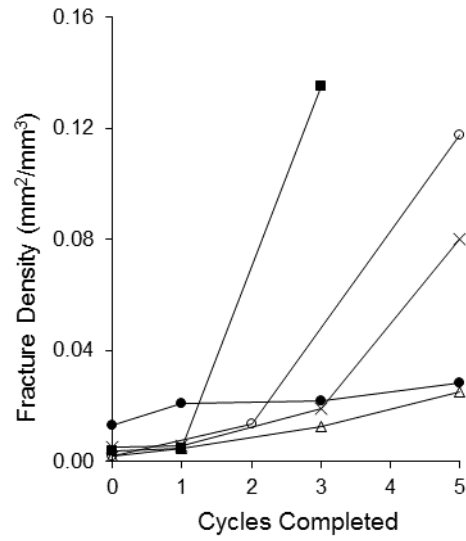
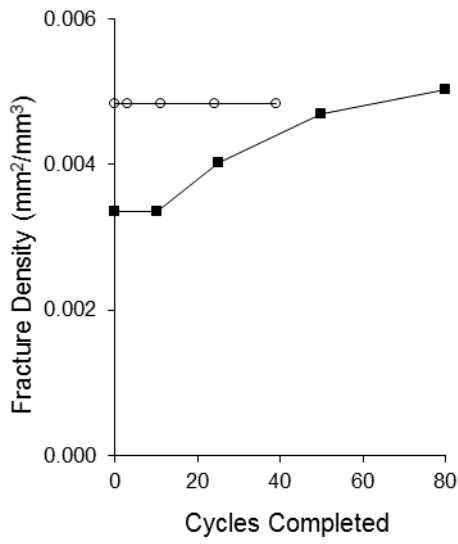
Figure 5a-c Fracture density due to experimental weathering of five limestones

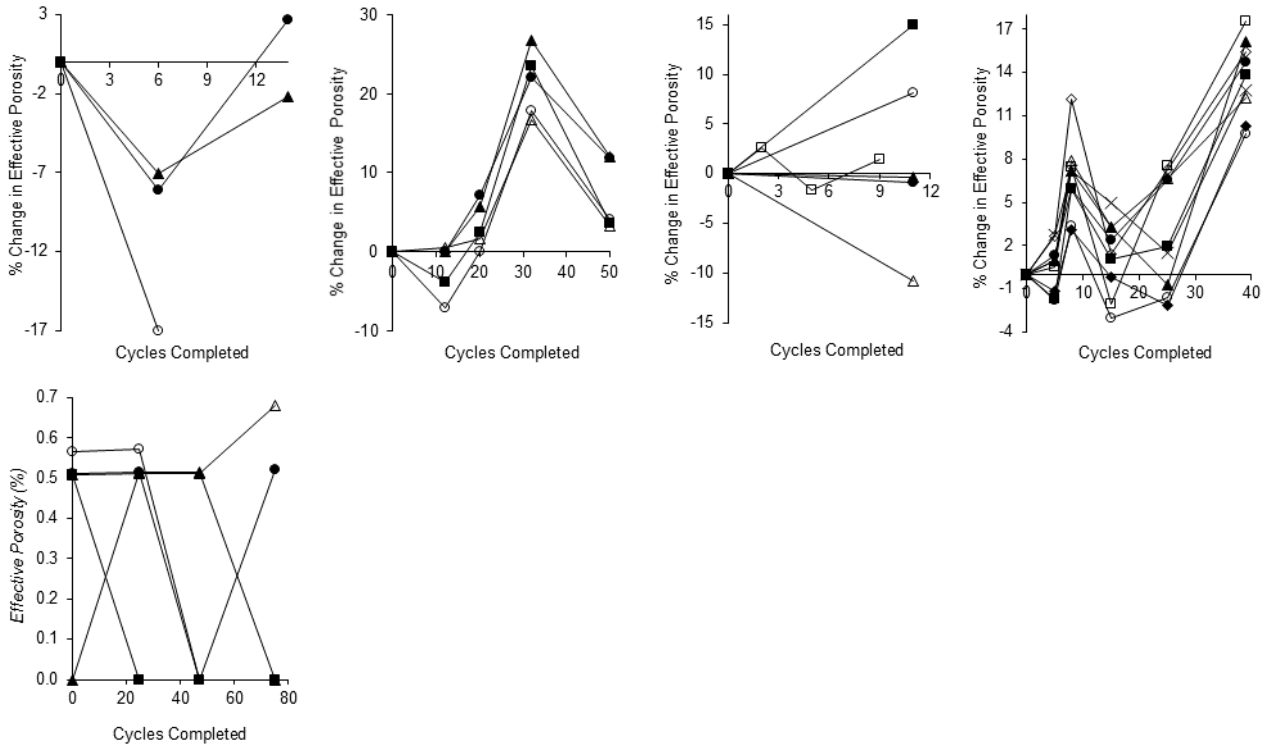
**Figure 6** Percentage change in effective porosity due to freeze-thaw  
 (\*Absolute effective porosity is plotted for SpaL because of the low values involved)

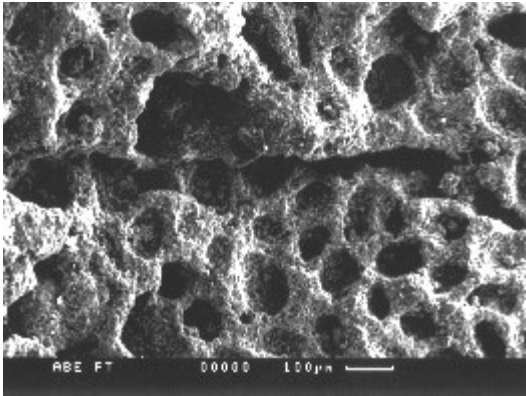
(a) MagL: Post freeze-thaw  
Development of this macro fracture appears to have been assisted by pore coalescence and alignment.

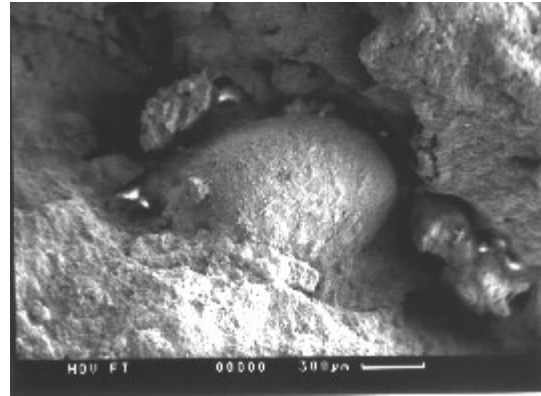
(b) OoL: Post salt weathering  
Low magnification micrograph of an ooid and surrounding debris covered with a fine coating of salt deposits.

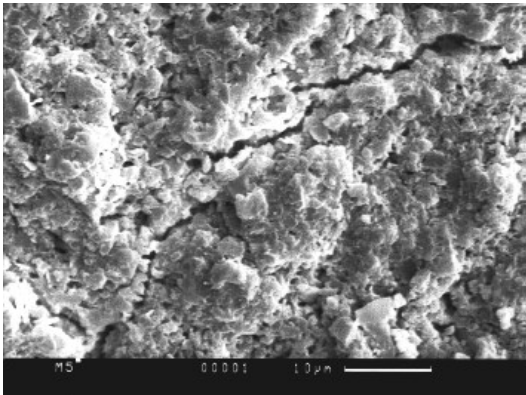
(c) HdCh: Post salt weathering  
Narrow microcracks with an aperture of 1 μm developed in *en echelon* form.

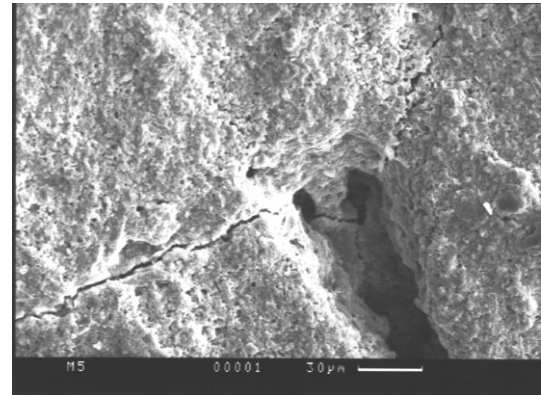
(d) HdCh: Post salt weathering  
Medium magnification view showing an irregular crack intersecting the blunt end of a much larger fracture. The latter appears to have propagated from two rounded pores.

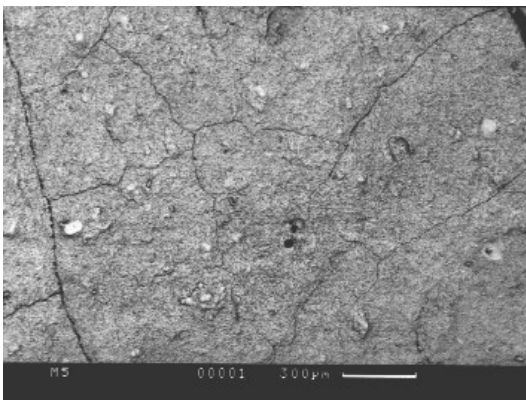
(e) HdCh: Post salt weathering  
Low magnification view of the surface of HdCh, dissected by a dense network of intersecting, irregular, angular and incipient fractures.

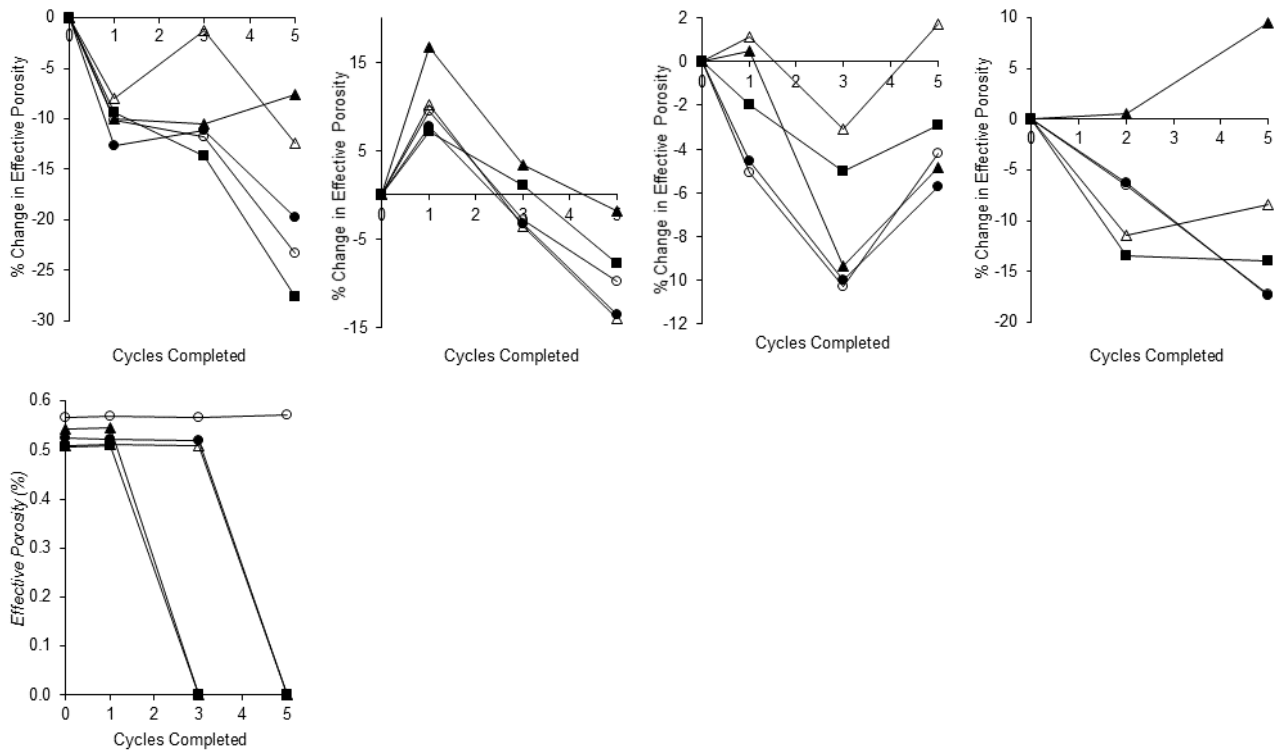
**Figure 8** Percentage change in effective porosity due to salt weathering  
 (\*Absolute effective porosity is plotted for SpAL because of the low values involved)

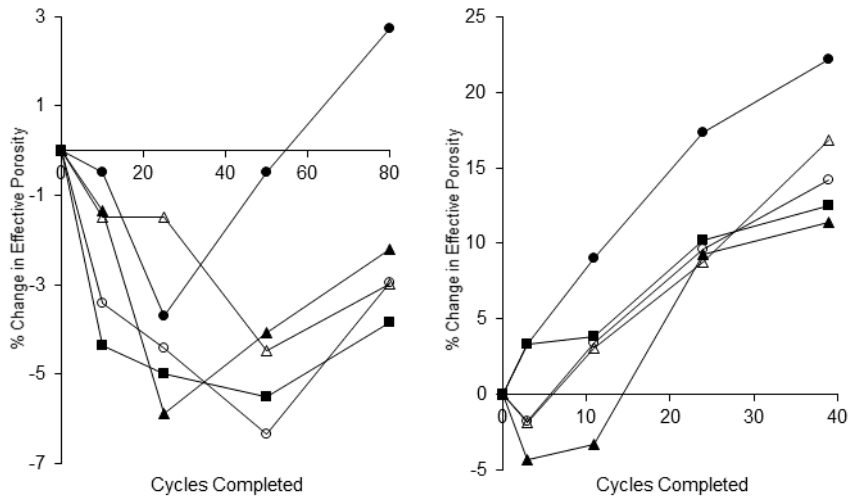
**Figure 9** Percentage change in effective porosity due to wetting and drying

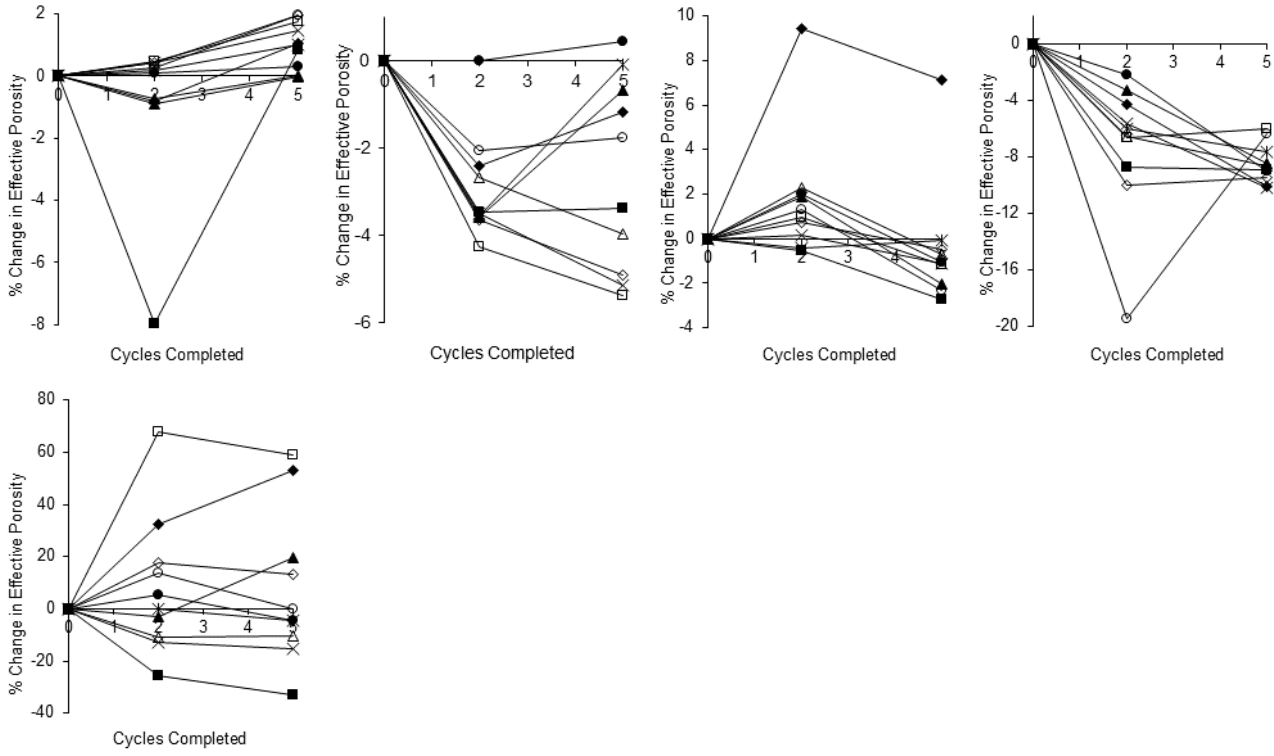
**Figure 10** Percentage change in effective porosity due to slake durability
