Khan, FN, Haider, J and Persson, M (2017) Investigating tool performance and wear when simulating bandsawing of nickel-based superalloy under interrupted orthogonal turning condition. Proceedings of the Institution of Mechanical Engineers, Part B: Journal of Engineering Manufacture, 233 (2). pp. 515-526. ISSN 0954-4054

Investigating Tool Performance and Wear When Simulating Bandsawing of Nickel-based Superalloy under Interrupted Orthogonal Turning Condition

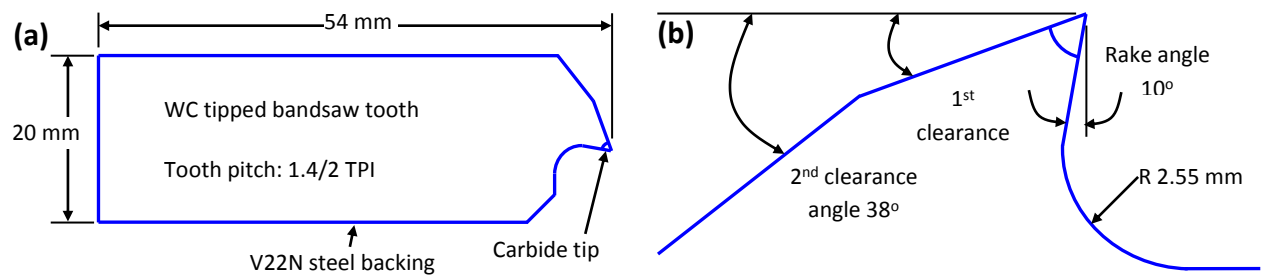
Figure 1. Schematic diagrams of (a) Bandsaw sample and (b) Carbide tooth tip geometries

Single bandsaw teeth made of tungsten carbide tips were employed for the machining tests. Figure 1 presents a schematic diagram of a bandsaw tooth highlighting the tooth geometry. **The tooth geometry is designed to efficiently cut large and difficult-to-cut materials such as Inconel for production cutting end-users. High-grade backing steel, and carbide tip materials in the teeth with optimum cutting edge produced by fine grinding give superior workpiece**

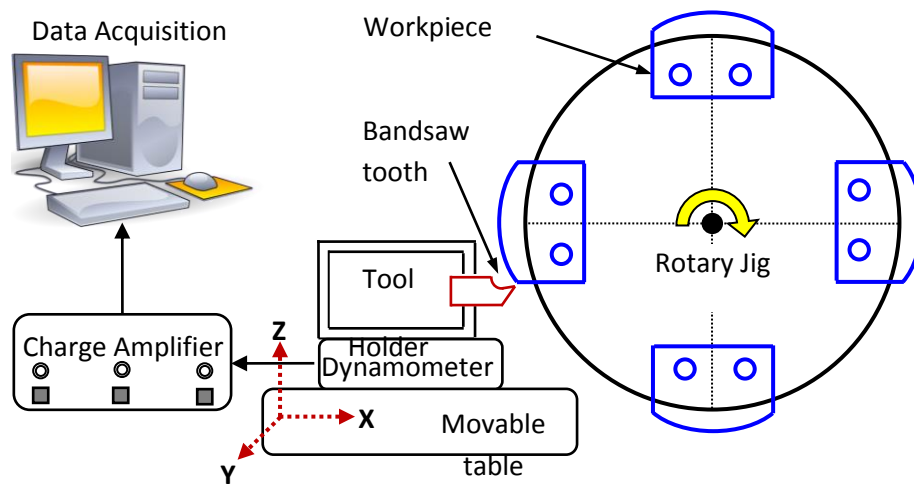
Figure 2. Schematic diagram of the machining test facility

In the current research work, the performance of carbide tipped bandsaw tooth while cutting Inconel 718 was evaluated using a “single tooth technique”³⁵. A schematic diagram of the machining test facility is presented in Figure 2. Separate workpiece sections were attached to the chuck to simulate the interrupted cutting action in bandsawing. Single tooth concept was also employed to understand other multipoint machining behaviour such as grinding of Inconel with a CBN grit³⁶. A single tooth test needs to be fully representative of the ordinary bandsaw product testing. The results that are produced need to be meaningful in order to replace the full bandsaw testing. Previous research dealt with the initial cutting action of single bandsaw teeth and correlated the performance of single teeth to the performance of the full product. It was found that a single tooth test can be employed to simulate the initial cutting action of the full bandsaw³⁵. However, despite having much similarity between the single tooth and full product tests, one should recognise some basic differences. For example, feeding bandsaw into workpiece is different in nature from that of a rigid lathe structure. The band saw can deflect under high feed rate pressure, which usually is not the case in more rigid set-ups such as lathe. In bandsawing, the depth of cut is determined by the force from the bandsaw and its cutting ability. Moreover, the width of the bandsaw can affect its cutting ability. Special attention should have been paid to the cross slide system in tool holder. Poor stiffness in the lathe cross slide system can produce backlash and hence there will be some degree of inconsistency in setting the depth of cut. Chips can move freely as no gullet was included in the single tooth and cutting takes place on the side of the workpiece in an open kerf situation unlike in actual bandsawing. These differences can affect the single tooth test results to some degree when compared with the full bandsawing.

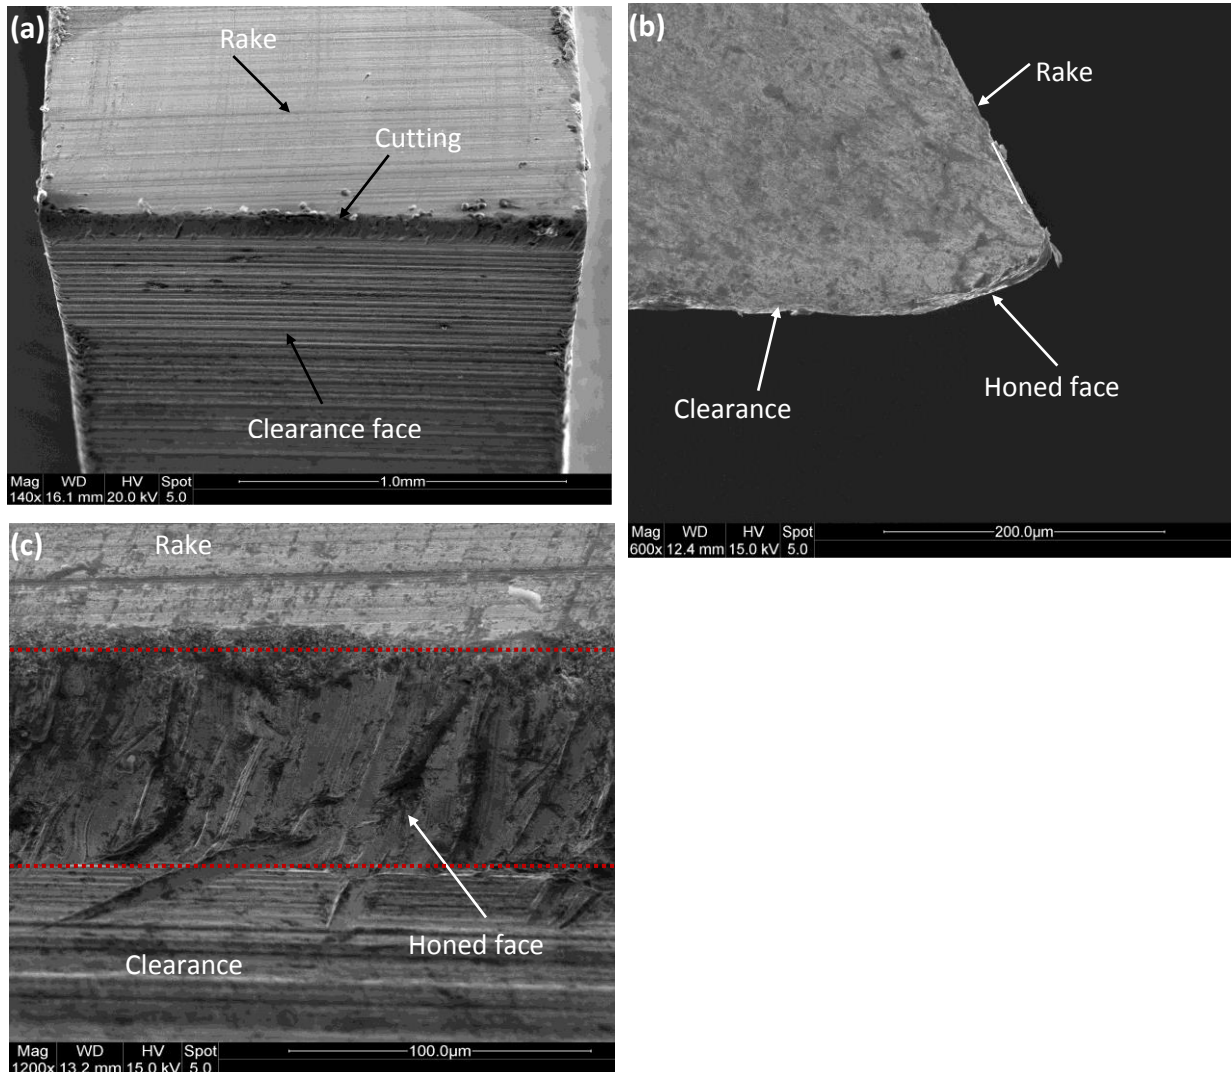
Figure 3. (a) Close view of the bandsaw cutting edge, (b) Side view of honed face and (c) Top view of honed surface

Figure 3(a) presents a typical SEM image of a bandsaw tooth, showing both the clearance and rake faces. The close view of the cutting edge appears to be free of any defects such as chipping. The average edge radius of the cutting edge was 13 μm when measured in the SEM. No sign of chipping was also observed in both rake and clearance faces. Horizontal grinding marks were clearly visible on the clearance face. However, no grinding marks were observed on the rake face due to an additional finishing operation performed during the bandsaw manufacturing process. This helps easy chip flow over the smooth rake face.

During the manufacturing process, the carbide bandsaw teeth were processed by a special edge modification operation to produce a small flat on the cutting edge. A diamond pad was pressed against the teeth while the band travelled slowly³⁷. On average, the operation created a flat length of approximately $120\ \mu\text{m} \pm 20\ \mu\text{m}$. The modified edge reduces the vibration at the beginning of cutting with a shorter running-in period and a much lesser chance of chipping the brittle carbide tip. The generation of flat was clearly visible from the side view of the magnified edge creating a new angle with the rake face (Figure 3(b)). However, the flat

surface appeared to be substantially rougher than both the rake and clearance faces. The surface was characterised by ploughing marks created by the diamond particles (Figure 3(c)).

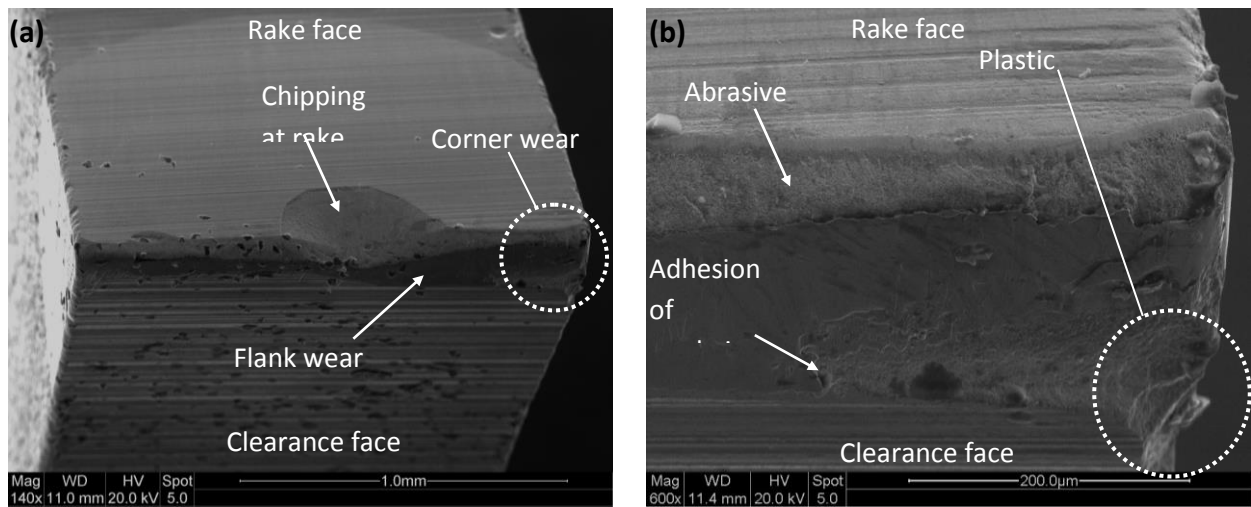
Figure 4. (a) Wear modes and (b) Wear mechanisms in carbide tipped bandsaw teeth

SEM image of the worn bandsaw tooth clearly revealed that flank wear was the dominant wear mode (Figure 4(a)). The image also showed that chipping occurred on the rake face due to the interrupted nature of the cutting process. Furthermore, the flank wear at the right-hand corner of the tooth was more prominent than the rest of the cutting edge. This corner wear was caused due to the cutting action by the set tooth. Flank wear developed at the cutting edge due to the abrasive action between the flank face and machined workpiece (Figure 4(b)). There was also a clear evidence of adhesion of workpiece material onto the worn flanks promoting the adhesive type wear. This is also evident from Figure 5, which shows adhering workpiece on the side face as well as on the flank face. Evidence of plastic deformation at the corner of the tooth was also found possibly due to the high mechanical and thermal stresses generated at the cutting edge.

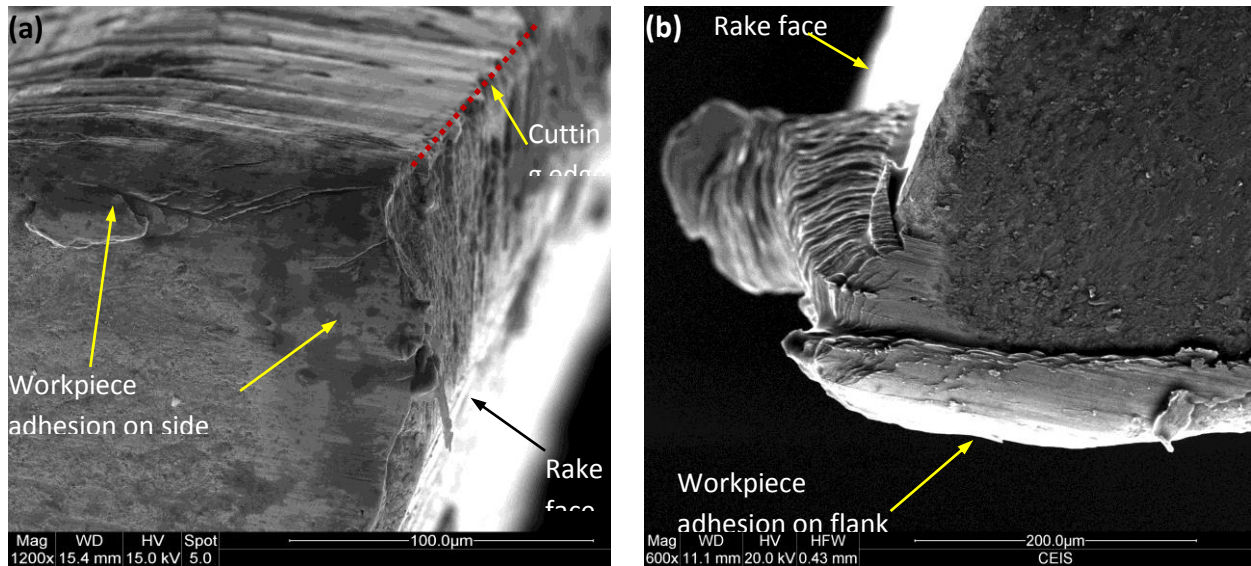
Figure 5. Adhesion of the workpiece (a) On the side face of tooth corner and (b) On the flank face

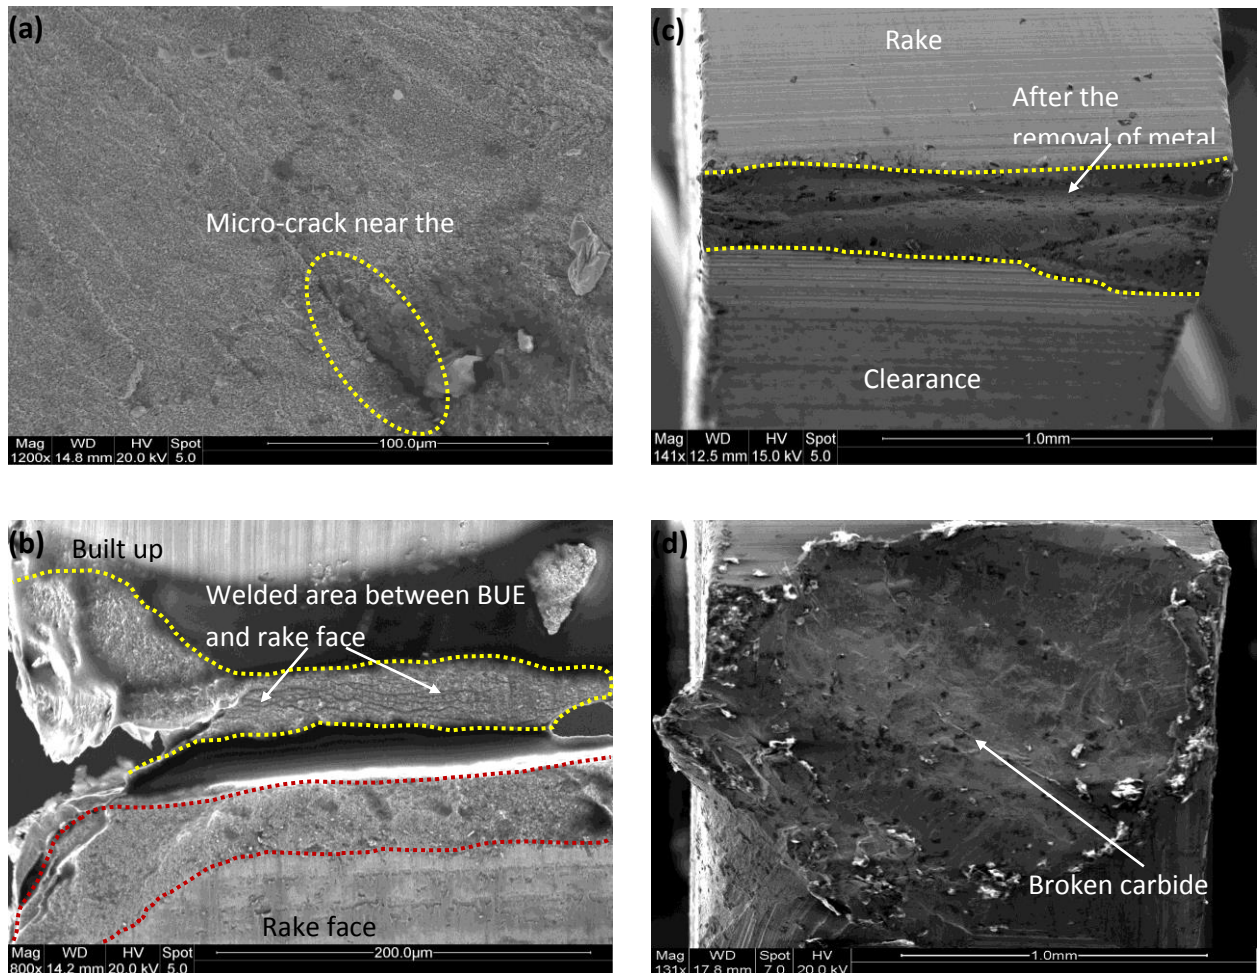
Figure 6. (a) Micro-crack formation on the rake face (b) Welded area between rake face and Built-up edge (BUE) (c) Cutting edge after removal of the BUE and (d) Catastrophic failure of carbide tip

The formation of microcracks in carbide tool is often observed in intermittent machining operation and has been reported previously. Microcracks observed in the bandsaw cutting edges (Figure. 6(a)) could further extend into the carbide tip during prolonged machining and finally leading to chipping of the edge, thus modifying the tooth geometry ³⁸⁻⁴⁰. The microcracks around the region of chipping propagate and can lead to subsurface fatigue cracks during prolonged machining. Owing to the poor thermal conductivity of the Inconel 718, very little heat is carried away by the chips or workpiece material. Therefore, a high temperature is generated at the tool-workpiece interface leading to welding of chips with the cutting edge as seen in Figure 6(b) ⁴¹. The high chemical affinity of the Inconel further accelerates the

welding and adhesion of the workpiece material onto the cutting edge. This welding process again accelerates the tool wear through the gradual removal of tool material with the chip during the machining process. Figure 6(c) shows that, in certain cases, the strongly welded chip can remove a big chunk of the tool material leading to a significant modification of the cutting edge. It was also noticed that after prolonged machining at high feed rate (30 μm), the carbide tip was completely detached from the backing material as evidenced in the SEM image of the broken tooth (Figure 6(d)).

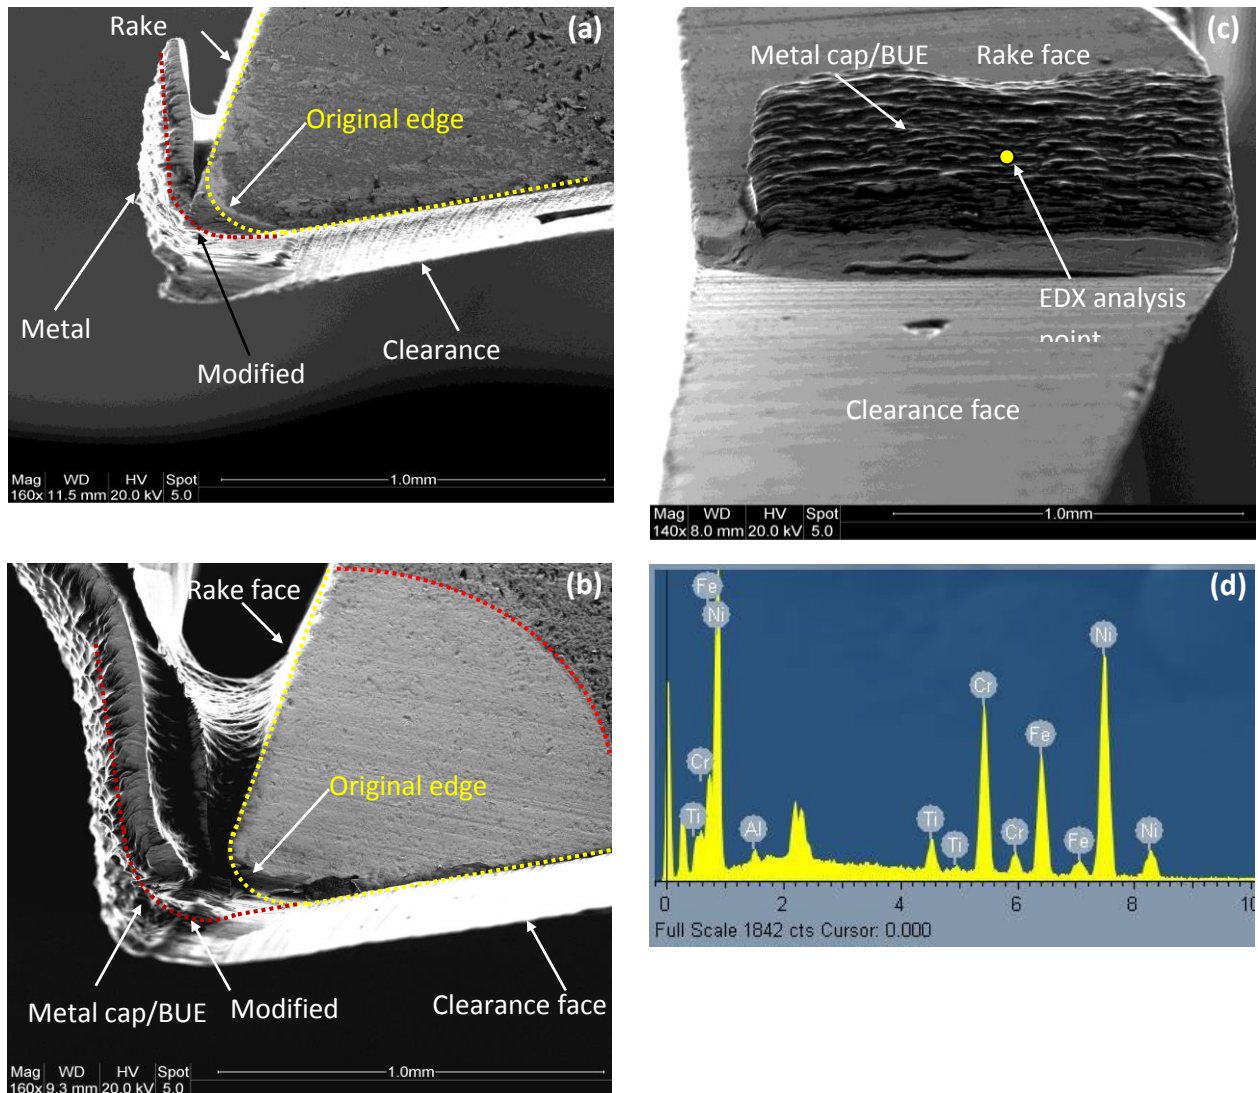
Figure 7. Metal cap or BUE formation due to the adhering of workpiece material to the carbide tooth when machining Inconel 718 (a) Side view: starting of BUE (b) Side view: fully formed BUE and (c) Top view of BUE and (d) EDX elemental map of BUE

After cutting approximately 500 sections (~ 75 m length of cut), a metal cap or built-up edge (BUE) started to form on the rake face of the tooth due to the welding of workpiece material by the high stress and temperature generated at the cutting edge (Figure 7(a)). As the machining progressed, the BUE gradually grew bigger in size as seen in Figure 7(b). The formation of built-up edge modified the cutting edge geometry leading to an effective blunt cutting edge with a higher edge radius, which would negatively affect the efficiency of the machining process. After continuing further cutting, it was observed that once the BUE reached a critical size, it was detached from the edge along with a fraction of tool material. This process further increased the wear at the cutting edge. Literature also reports the similar dynamic and cyclic BUE formation in three distinct stages (initiation, growth and breakage) ⁴² BUE formation can also be related to the periodic machine vibration possibly due to the significant reduction in the cutting ability of the modified cutting edge. The EDX analysis of the BUE revealed that the chemical composition of the BUE was similar to the workpiece material (Figure 7(d)). It was also interesting to note that on the rake face close to the carbide tip, the attached workpiece material apparently flowed in the gap between the BUE and rake face and formed a strong bond.

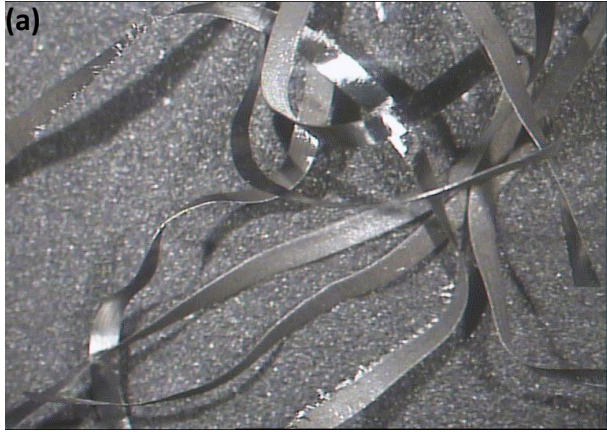
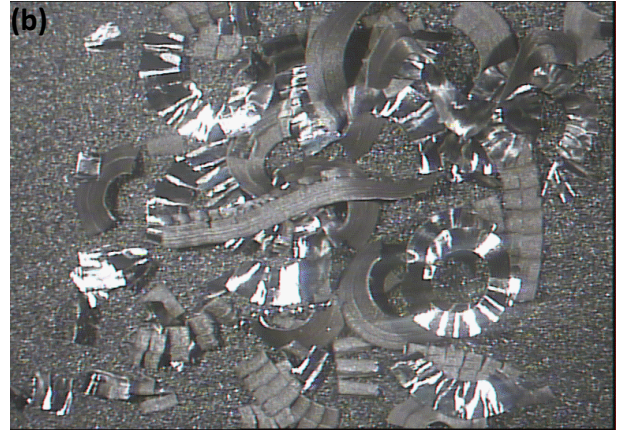
Figure 8. (a) Continuous chips and (b) Fragmented chips generated at the new and worn conditions of the bandsaw teeth respectively (Magnification $\times 10$)

The cutting edge condition of the bandsaw affects the chip formation process. At the new condition of the tooth, sharp cutting edge led to the formation of continuous chips indicating an efficient cutting process (Figure 8(a)). On the other hand, short lumpy chips were formed when the cutting edge became blunt with a higher edge radius (Figure 8(b)). By observing the chips formed during bandsawing under the SEM, it can be seen that the back surface of the BUE (Figure 9(a)) is smoother and shinier compared to the free surface (Figure 9(b)). This can be attributed to the high contact stresses and friction between the rake surface and the flowing chip ⁴⁵. On the free surface and side of the chip, it was noticed that very thin and closely packed lamellas were formed possibly due to micro level localised shear deformation (Figure 9(a) & 9(c)). In this case, the absence of pronounced serrated type chips can be explained by the fact that depth of cut, cutting speed, and the ratio between depth of cut to edge radius are much smaller in bandsawing compared to the conventional machining operations.

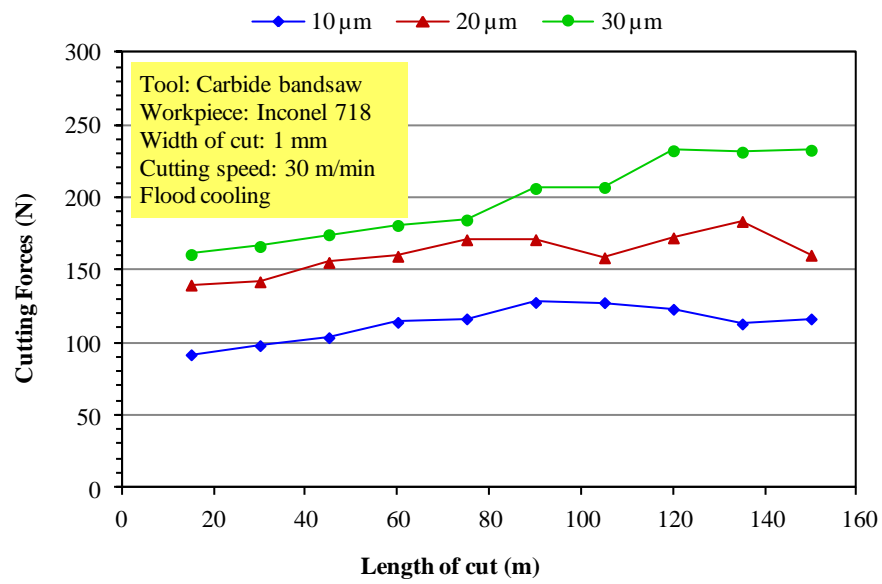
Figure 10. The variation in cutting forces with the length of cut at different depths of cut

It is a well-known fact that forces are strong indicator of cutting performances such as tool wear, surface finish, specific cutting energy etc. The development of cutting forces in the bandsaw teeth during the selected length of cut (150 m) at different feeds or depths of cut are plotted in Figure 10. The force components increased steadily with the length of cut, which indicated the gradual degradation and wear in the cutting edge. At the beginning of the machining test, the tool edge is relatively sharp and hence produces lower cutting forces⁴⁶. As the test progresses, the edge wear increases leading to a blunt edge with increased contact area between the edge and the workpiece and also produces higher cutting forces. Therefore, the forces served as a good indicator of the degradation of the cutting edge throughout its life. Similar results were found by Sarwar et. al.²⁵⁻²⁶ during the machining of steels with HSS bandsaws.

It was also noticed that at 10 μm depth of cut, the cutting forces reached the peak point after cutting 90 m and then gradually decreased to lower values. It was evident that after cutting approximately 75 m, the workpiece material started adhering to the rake face forming a metal cap or BUE (see Figure 7). The BUE modified the geometry of the cutting edge (i.e., blunting and formation of higher edge radius) leading to higher forces in the tooth. Once the BUE was removed from the cutting edge, the forces started to decrease owing to the improved condition of the cutting edge or a decrease in depth of cut resulting from chipping or fracturing of the cutting edge^{3, 46}. However, the forces at this point were still higher than the forces experienced by the carbide tooth at the start of the cutting operation possibly owing to the wear or chipping taken place at the cutting edge. Similar fluctuations in the cutting forces were also noticed during the tests with the other depths of cut employed.

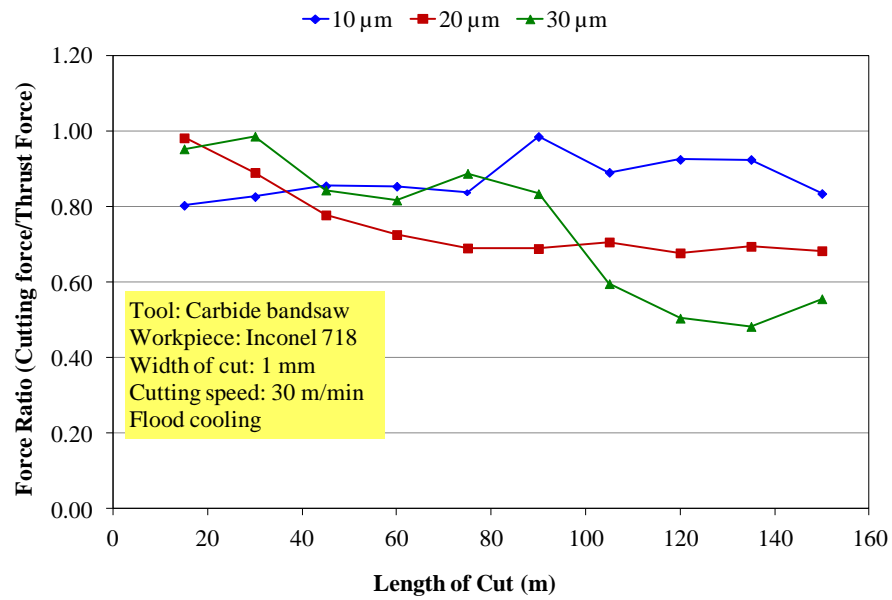
Figure 11. The variation in force ratio (Cutting force/Thrust force) with the length of cut at different depths of cut

The variation in force ratio (Cutting force, F_c /Thrust force, F_t) with the length of cut is shown in Figure 11 and it is considered an important parameter since it can affect tool performance, tool wear and surface integrity of the machined surface. In all cases during the machining tests, the force ratio was less than one suggesting that the thrust force was higher than the cutting force. A number of factors can be associated with this unusual phenomenon with respect to bandsawing.

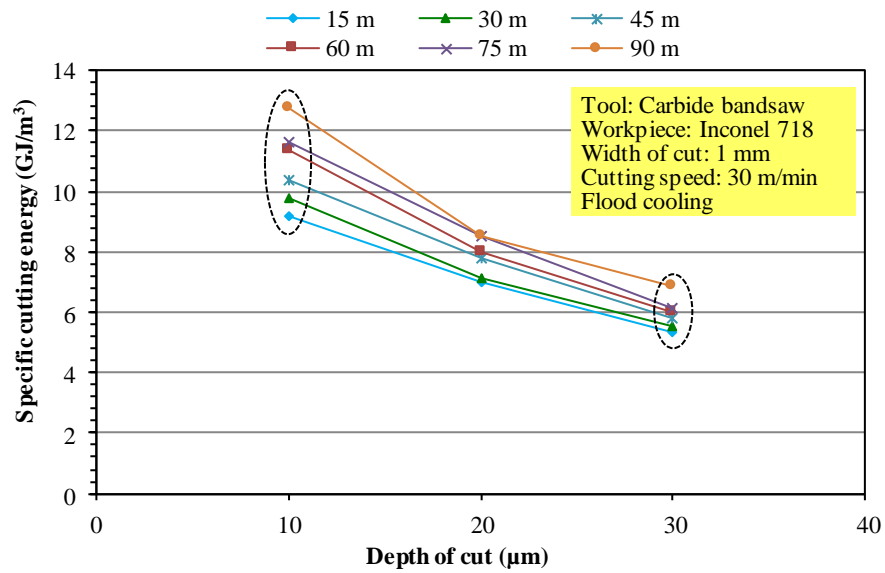
Figure 12. The variation in specific cutting energies with the depths of cut at different lengths of cut

Specific cutting energy (E_{sp}) is defined as the energy required to remove a specific volume of workpiece material. E_{sp} is a quantitative way of measuring machining efficiency and can be used for assessing the condition of the cutting edge during cutting operation ²⁷. The E_{sp} parameter is particularly suitable for measuring bandsawing efficiency due to the low depth of cut compared to the bandsaw edge radius. Figure 12 presents the variation in specific cutting energy with the depths of cut at different cutting lengths. It is very clear from the figure that higher depth of cut reduces the specific cutting energy or improves the bandsawing efficiency. On average, a 45% decrease in specific cutting energy was observed with the increase in depth of cut from 10 μm to 30 μm . However, it should be noted that higher depth could result in a premature failure of the bandsaw teeth. This condition is not desirable in practical bandsawing point of view due to the fact that the failure of one tooth in a bandsaw loop can cause catastrophic failure of the entire bandsaw loop. It was also observed that E_{sp} at a particular depth of cut increases with the length of cut due to the wear and degradation of the cutting edge. E_{sp} is also more sensitive to a lower depth of cut as evidenced by a greater change in the E_{sp} values at 10 μm depth of cut compared to that at 30 μm . At 10 μm depth of cut, cutting edge radius is equal to or even higher than the depth of cut.

suitable for machining Inconel 718. This can be explained by the fact that at a higher depth of cut, a combination of high cutting force and heat generated in the cutting tool causes the rapid degradation of the cutting edge and finally catastrophic failure of the tooth results. However, at a lower depth of cut, tool life can be significantly extended. Therefore, based on the E_{sp} results obtained with the range of parameters investigated, it can be concluded that depth of cut in combination with the other fixed cutting parameters should be lower than 20 μm in order to achieve the reasonable productivity with minimum tool failure.
