Liskiewicz, T and Kubiak, K and Comyn, T (2017) Nano-indentation mapping of fretting-induced surface layers. *Tribology International*, 108. pp. 186-193. ISSN 0301-679X

Nano-indentation mapping of fretting-induced surface layers

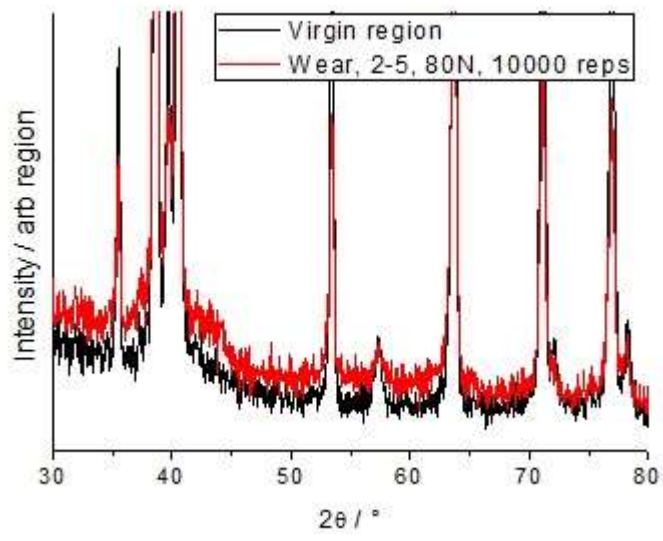
Figure 6

Fig. 6. XRD spectrum for Ti6Al4V; dark line – virgin region of the sample; light line – worn surface.

No change in peaks position, breadth, shape or relative intensity was observed for Ti6Al4V alloy between the wear region and virgin sample surface. However, the intensity of peaks was reduced uniformly (Figure 6). Relatively large increase in background signal was observed at all angles, and particularly centred on $2\theta = 40^\circ$, which may be interpreted by amorphous layer formed at surface, obscuring the crystalline sub-layer structure. The penetration depth normal to the sample surface vs. diffraction angle can be calculated using mass absorption coefficients, with the knowledge of angle, material and density [17]. By doing so, it has been revealed that

at 40°, near strong Bragg peaks, 99% of diffraction occurs at a depth <8.9 μm from the surface (value based on 99% absorbed and 1% transmitted signal).

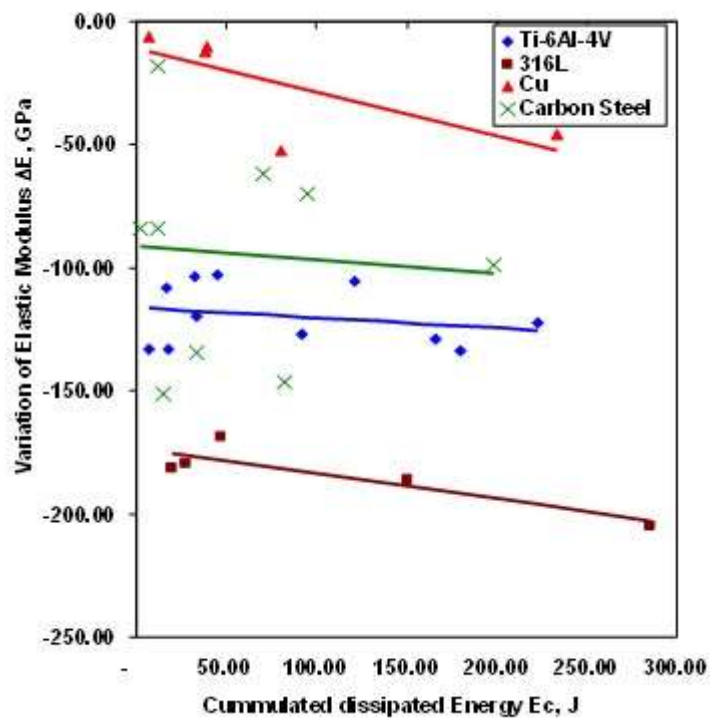
Figure 11

Fig. 11. Variation of Elastic Modulus for four tested materials as a function of cumulated dissipated energy.
