Two-layer laser clad coating as a replacement for chrome electroplating on forged steel

Peter Christoforou, Robert Dowding, Christoforou Pinna and Roger Lewis

Proc IMechE Part C:

DOI: 10.1177/09544062211010853

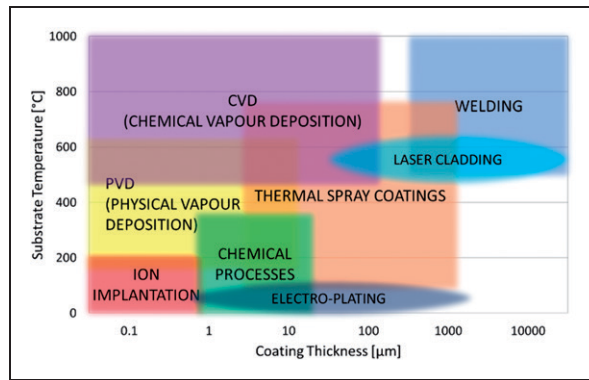
Figure 1. Coating process comparison map, adapted from Sulzer-Metco⁴ with additional sources.^{1,5–8}

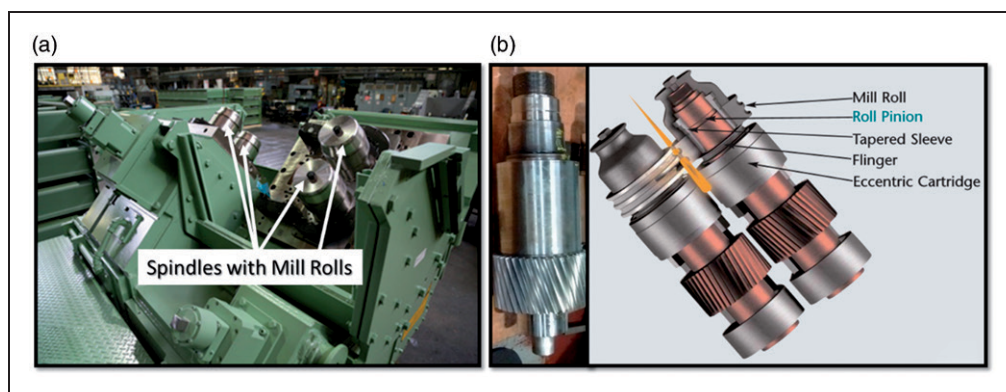
Figure 2. Images courtesy of Primetals Technologies© (a) Pinions lined up for inspection; (b) rod mill pinion and assembly diagram.¹⁷

A pinion is a critical component used in the rolling of long products. Pinions drive the mill roll (see Figure 2(b)), which is used to shape steel products such as round bar. The mill roll has grooves machined into the running face and when two mill rolls are positioned close to each other and parallel to their rotational axis, together they form oval or round patterns from which the steel products can be shaped accordingly. Multiple pairs can be arranged in a production line, as shown in Figure 2(a). The pinion is supported by two hydrodynamic bearings (eccentric cartridge in Figure 2(b)) and it is driven by a spiral gear in the middle. Typical product temperatures exceed 750 °C in order to provide thermo-mechanical rolling, with a typical round bar diameter of 5.5–28 mm and at a maximum rolling speed of 120 m/s. In addition, the rolling force (mill roll separating force) can be up to 394 kN,¹⁷ but typically in hot rolling the separating force can be lower. The mill rolls require replacing from time to time and production line downtime must be kept to a minimum. A taper sleeve is used to mount the mill rolls onto the pinion, with the use of a hydraulic tool that slides the sleeve into position by “wedging” it between mill roll and roll pinion to create an interference fit. This enables a quick removal, thus reducing downtime of the production line. However, the quick removal method of the taper sleeve causes mild wear and often sever damage is cause by particle pick up. Chrome electroplating of the pinion’s surface has been successful for extending the pinion’s life, by providing a new, harder surface. Although the chrome layer can be repaired repeatedly, it is not a sustainable process with a limited number of possible repairs.

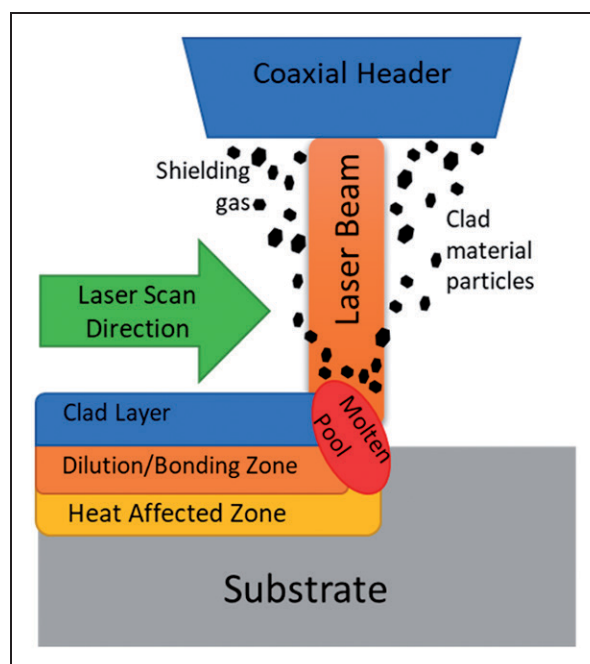
Figure 3. Laser cladding blown powder method.

Lasers have been used extensively to improve wear and corrosion resistance of mechanical components, either by laser hardening (post-heating, stress-releasing) or alloying of different powders as a coating on existing components. Similar to welding, laser cladding is a manufacturing process which metallurgically bonds materials or alloys onto a base material, but with a laser beam as a heat source which creates a melt pool with minimal heat affected zone (HAZ) due to the precise control of the heating parameters. Figure 3 is a schematic of the laser cladding blown powder method used for producing clad test specimens used in this study.

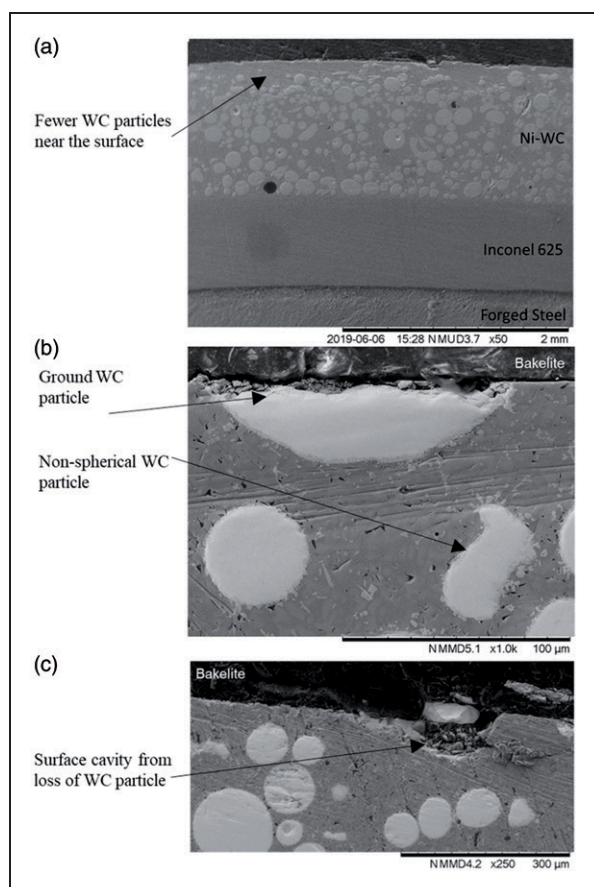
Figure 4. (a) Cross-section image of the clad layers taken with SEM Hitachi TM3030Plus at 50 \times ; (b) ground WC particle in Ni-WC matrix coating; (c) post grinding WC particle cavity in Ni-WC matrix coating.

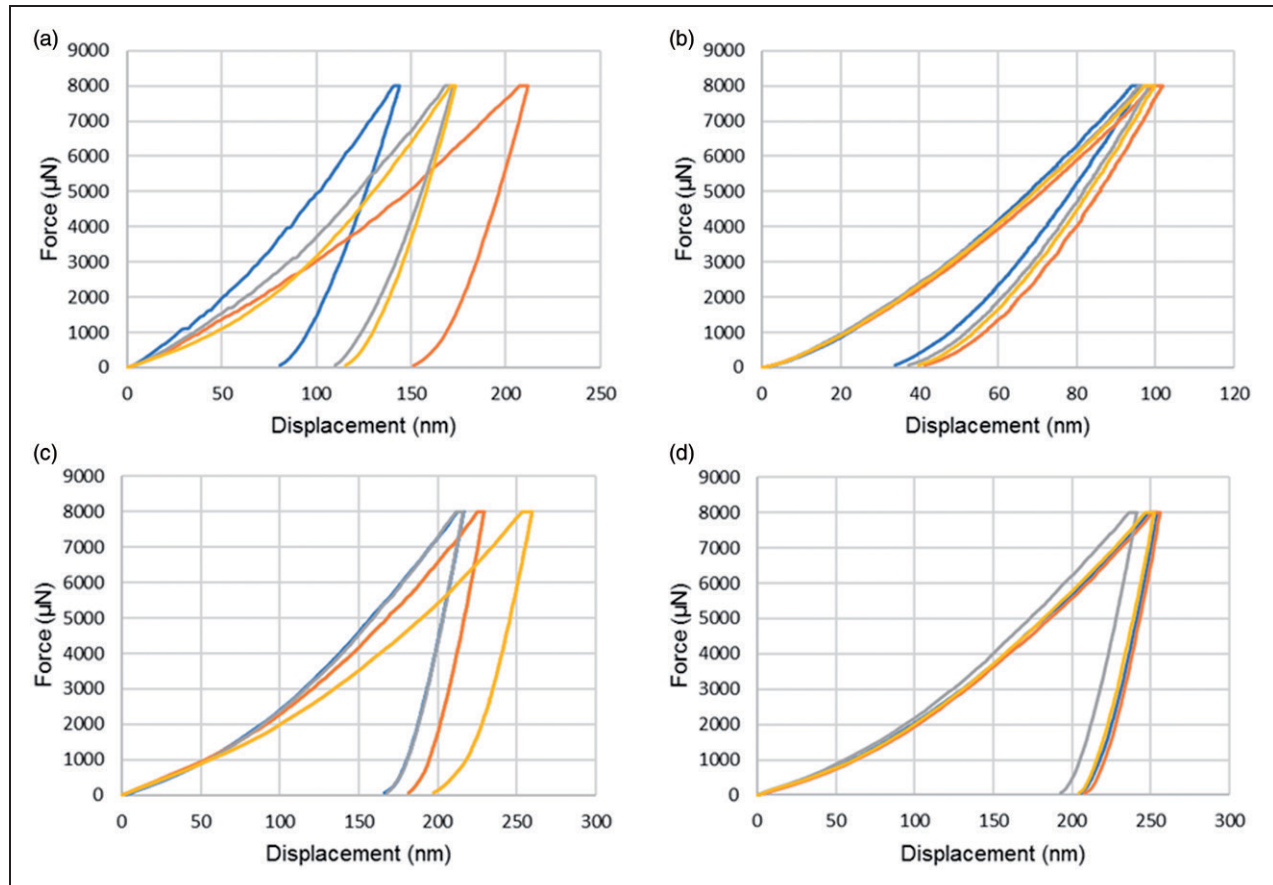
**Figure 5.** Force vs displacement graphs for different regions in the clad material: (a) Ni-WC matrix; (b) WC particles; (c) dilution zone between Ni-WC and Inconel 625; (d) Inconel 625.**Table 3.** Mechanical properties for coatings and substrate.

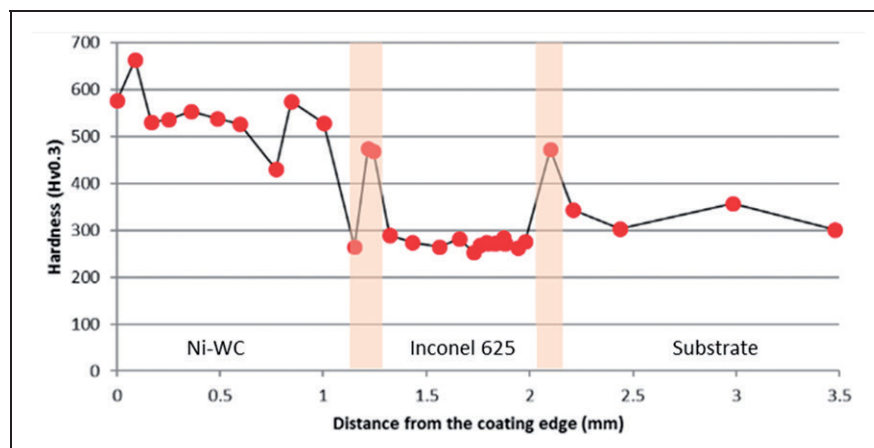
Figure 6. Microhardness through the coating layer section (WC regions excluded).

The through thickness hardness of the two coatings and substrate was captured with a hardness test as shown in Figure 6. The graph is split into three distinct regions, the first is the Ni-WC coating where the average hardness is 550 Hv. The WC spherical particles hardness measurements were excluded from this graph and shown in Figure 7. The middle region in Figure 6 is the intermediate coating layer of Inconel 625, with an average hardness of 272 Hv and the region on the right belongs to the substrate material with an average hardness of 325 Hv. Two regions have been highlighted, which indicate a transition from one coating to the next, these are the dilution zones. They are characterised by either a sharp rise in hardness or a sharp drop, followed a sharp rise. The laser clad coatings (Ni-WC matrix and Inconel 625) exhibit the desired hardness of a harder outer coating with a softer intermediate coating and their dilution zones are in the region of 5% of the coating thickness.

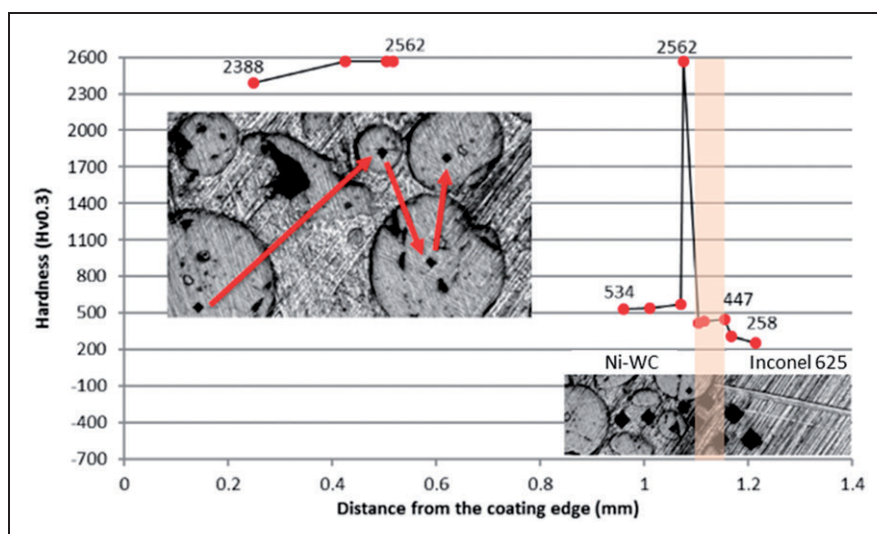
Figure 7. Microhardness on WC (left) and dilution zone (right).

The hardness measurements on WC spherical particles are shown in Figure 7, with an average hardness

of 2500 Hv. On the same graph the dilution zone hardness between the two clad layers and the corresponding image is shown. The spike is a measurement on a WC particle. The hardness in the dilution zone changes in stages, with values exceeding 500 Hv on the Ni-WC, in the region of 450 Hv on the dilution zone (highlighted area) and below 300 Hv on the Inconel 625.

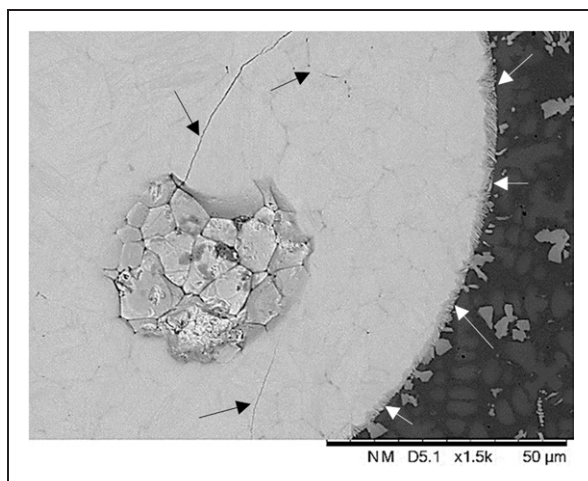
Figure 8. WC particle: detail of microstructure formation.

SEM optical microscope images were obtained for surface analysis. Figure 8 is an SEM image in the BSE mode, showing the WC particles and surrounding Nickel-based alloy. The WC particle contains multiple micro-cracks (indicated by black arrows) due to its brittle nature and there is a sharp transition with the surrounding alloy (indicated by white arrows).

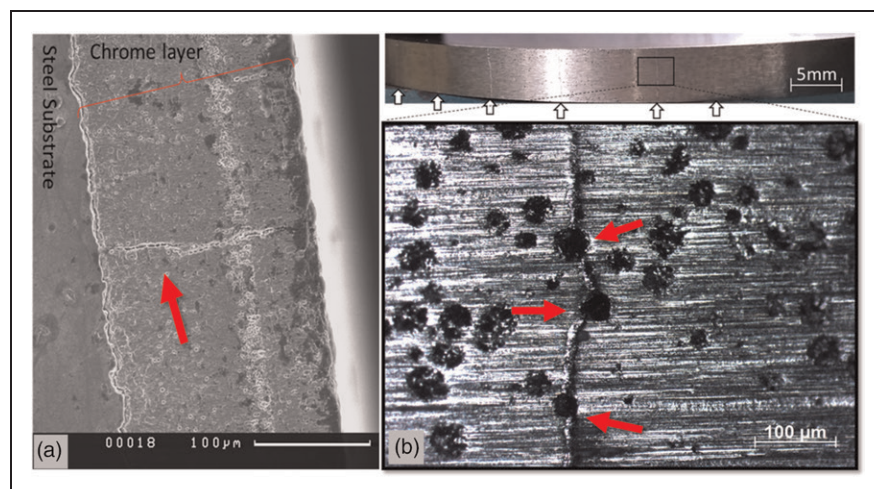
Figure 9. (a) Micro-cracks on the chrome layer prior to testing; (b) Clad surface crack, as found in multiple locations on the surface.

Both coating techniques are expected to contain micro cracks. This might be a result of the brittleness of the chrome or because of the rapid cooling of the laser clad process. Surface cracks were present in the chrome plated pinion, which is the reason it was taken out of service in the first place. Micro-cracks on the

chrome layer have been identified with SEM at various locations and with large distance between the cracks in comparison to the crack length. Some cracks extend through the thickness of the chrome layer and it is unclear how much the Electrical Discharge Machining (EDM) process, which was used to produce the test specimens, has contributed to cracking. An example is shown in Figure 9(a). Although the clad coating had no surface cracks after the cladding process, new cracks appeared on the test specimens after machining using the EDM. Figure 9(b) is a close view of a surface crack in the clad test specimen, where arrows point out individual surface cracks. The gap distance between the surface cracks was measured using a micrometre and was found to be around 3.5 mm–5 mm. The cracks seem to be superficial and when observed carefully, the crack path is parallel to the pinion's axial direction. It is also influenced by the nearest surface pitting cavities. Very few cracks extend through the thickness of the top clad layer. A clad mounted sample was identified that had a crack through the top clad layer, as shown in Figure 10. It can be observed here that a small fraction of the surface is raised while the crack is closed, which is one of the factors that make the cracks visible from the surface, as opposed to an open crack that would generate a surface groove. Hydrodynamic lubrication forces are exerted on this surface during service and a raised surface is preferable to an open crack since the hydrodynamic forces may contribute to crack propagation of the open crack tip.

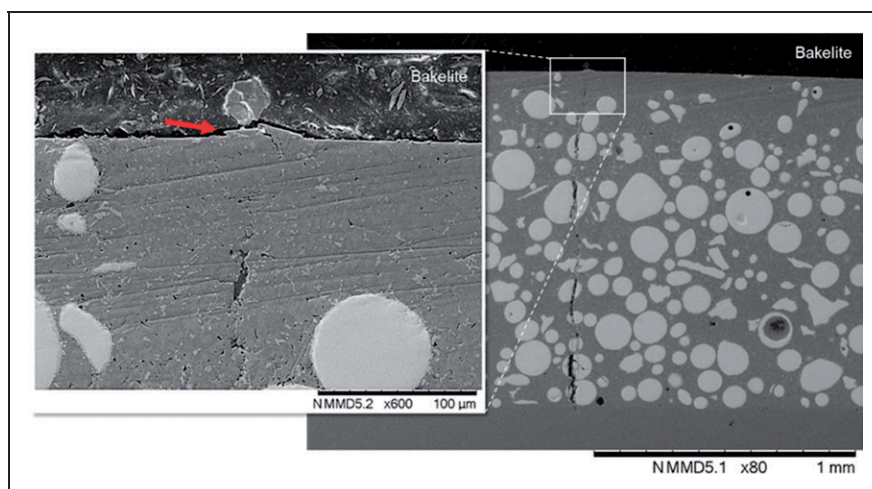
Figure 10. Crack through the Ni-WC matrix.

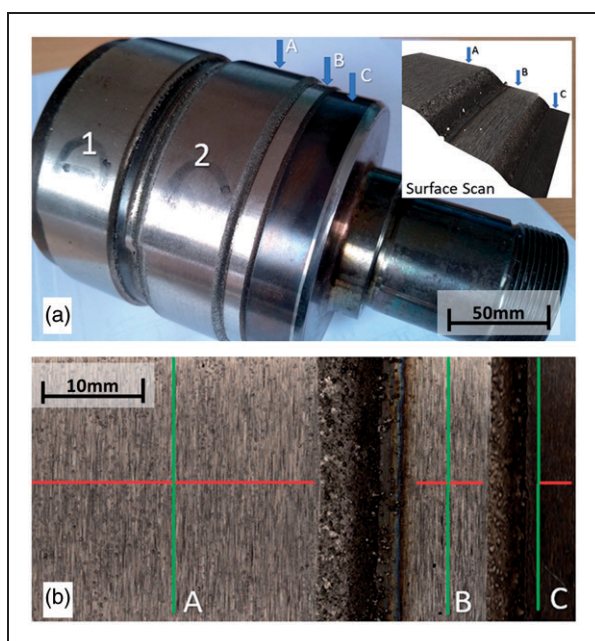
Figure 11. Image of cladded pinion (a) and corresponding top view of the Alicona scan surfaces A, B and C (b).

The laser clad pinion sample is shown in Figure 11. An area of 20 mm × 10 mm was scanned for surface roughness using the Alicona InfiniteFocusSL, see reference surface scan in Figure 11(a) and top view of the scan in Figure 11(b). Test specimens from area 2 of the pinion sample were used for roughness and micro-hardness measurements. The corresponding

3D scan image on the top right is taken from this scan. The 2D image of the scan is shown at the bottom of the figure. Surface A is the Ni-WC matrix layer, surface B is the Inconel 625 intermediate layer and surface C is the substrate. All three surfaces were ground on a cylindrical grinding machine, using a diamond grinding disc. The stepped surfaces between A–B and B–C in Figure 11 are the untreated clad surfaces and hence they have a rough texture. The horizontal lines in Figure 11 indicate the measurements parallel to the pinion's central axis (in red) while the vertical lines are measurements parallel to the circumference/perpendicular to the pinion's central axis (in green). The results are shown in Figure 12 in Rz (peak height), Rq (root-mean-square) and Ra (average) roughness of profile in μm . The “Work roll

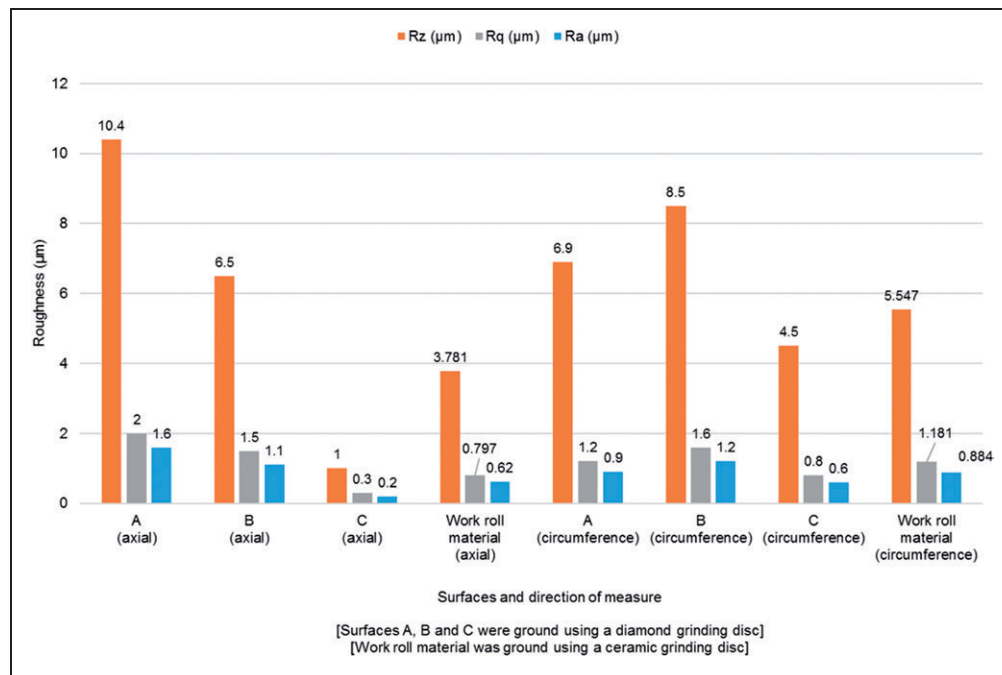
Figure 12. Roughness measurements.

material” figures are roughness measurements taken from cylindrical specimens of $\phi 45\text{mm}$ from parallel tests of Ni-WC matrix applied on work roll material used in the steel industry. The surface on these cylindrical specimens was ground using a ceramic grinding discs as opposed to a diamond disc. The surface finish was found to be significantly smoother in the axial and circumferential direction, which is preferable for the interaction of the surface with the bearings during industrial operation.

Generally, the chrome plating finish roughness is about $0.1\text{--}0.2\text{ }\mu\text{m Ra}$. A surface roughness of up to $0.6\text{ }\mu\text{m Ra}$ would be acceptable for parts of the pinion surface that are in direct contact with bearing components. This is to ensure a smooth surface, free from large asperities that may contribute to material pick-up during mounting and dismounting of the tapered sleeve. The resultant roughness was found to be $1.6\text{ }\mu\text{m Ra}$ in the direction parallel to the pinion's axis and $0.9\text{ }\mu\text{m Ra}$ in the circumferential direction. The roughness and pitting on the surface are probably caused by the grinding process, with the removal of WC spherical particles near the outer clad surface. Such surface roughness values are not acceptable for direct contact with the bearings. However, clad work roll material from a parallel study shown in Figure 12 has shown an improvement in the surface roughness with values of $0.62\text{ }\mu\text{m Ra}$ in the axial direction and $0.88\text{ }\mu\text{m Ra}$ in the circumferential direction.

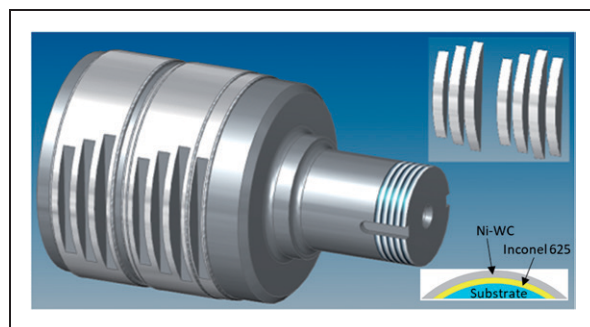
Figure 13. Diagram of various test specimens taken from the clad pinion using EDM.

Test specimens were taken from a roll pinion which was taken out of service due to cracking in parts of the pinion. Two sets of test specimens were made. One set of test specimens was taken from the chrome plated surface, while the second set of test specimens were from a pinion where two layers of laser clad coatings were deposited in two separate batches (see Figure 13). The laser cladding was

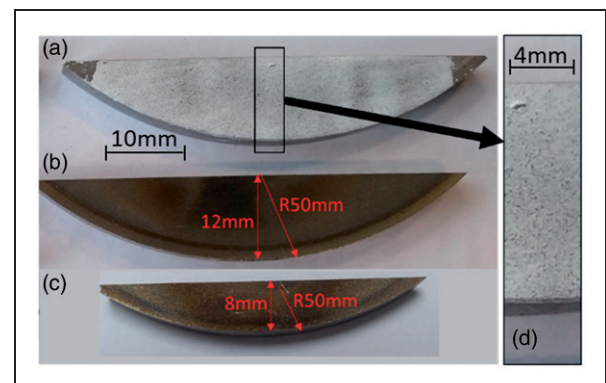
Figure 14. Laser clad test specimens of 5 mm thickness, macro (a) and (b) at 12 mm height and micro (c) at 8 mm height.

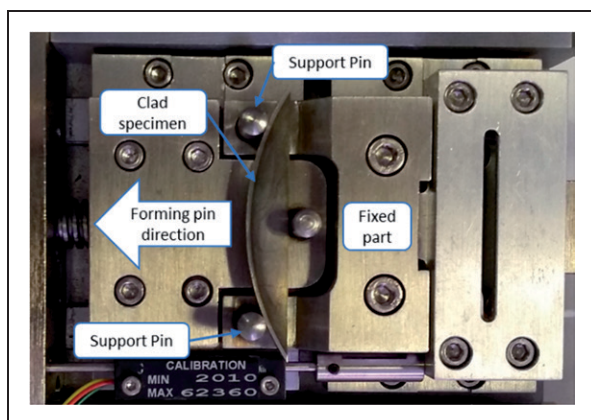
Figure 15. Test specimen loaded onto the SEM bending stage.

Preliminary tests on a three-point bend test in the Camscan series 2 Scanning Electron Microscope³¹ were performed with a chrome test specimen from an out of service pinion sample. The test specimens had undergone preparation revealing the microstructure and were observed under load with a speed of 0.1 mm/min, on a tooling geometry with 5 mm diameter pins and a 37 mm spacing between the collinear support pins which were in contact with the coated concave face, see Figure 15. Although an effort was made to produce thin test specimens to allow bending at lower force, the bending module reached the end of

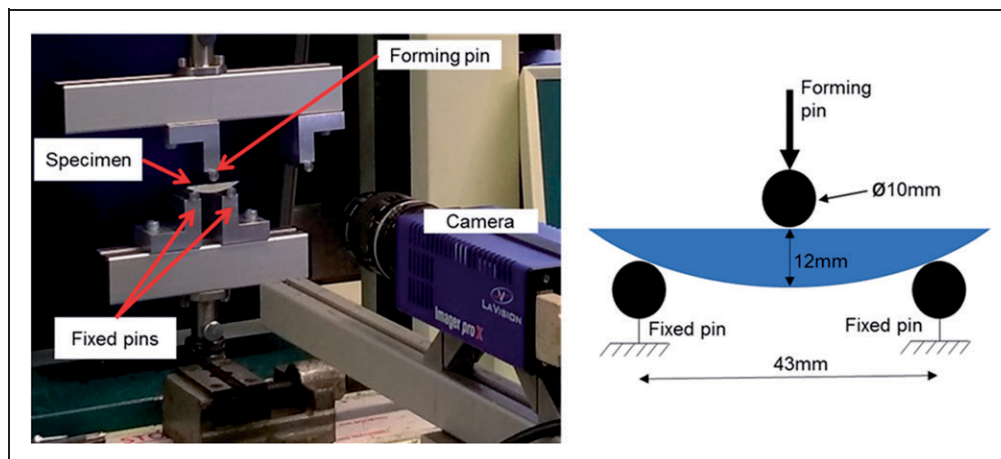
Figure 16. The Tinius Olsen H25IS UTM and LaVision camera used for the three-point bend test (left) and schematic diagram (right).

A UTM is typically used for flexural tests to obtain the modulus of elasticity in bending, flexural stress and strain. In this study the micro-crack bend test was used to intensify the stress in a selected volume of the test specimen in order to generate cracks and to identify the coating's resistance to crack initiation and propagation. In addition, strain was measured for direct comparison between the two test specimens. The Tinius Olsen H25I S machine was used for the test, which is a bench mounted electro-mechanical machine capable of up to 25 kN loading force, either in tension or compression. A load cell is available for measuring the loading force. Figure 16 is an image of the testing equipment and corresponding schematic diagram of the three-pin arrangement. Repeat tests were performed to breaking point of the test specimen by displacement control at a displacement rate of 0.04 mm/s. Two collinear pins of 10 mm diameter were in contact with the curved face of the test specimens and at a distance of 43 mm between them. The forming pin was in contact with the flat face, aligned with the centreline of the test specimen, see Figure 16 (right).

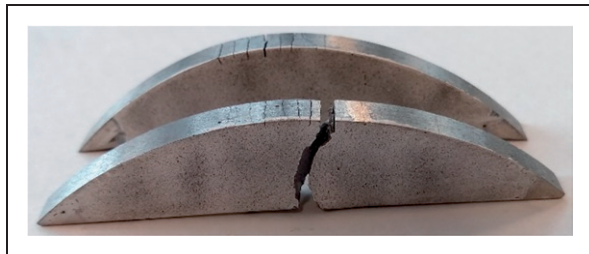
Figure 17. Multiple cracks through the clad layer and total fracture offset from the centre.

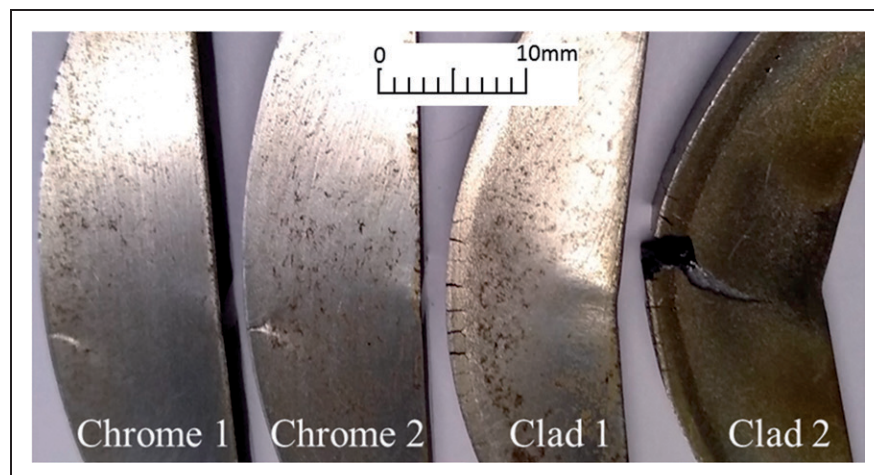
Figure 18. Test specimens from UTM 3-point bend test.

The Clad 2 test specimen in Figure 18 was driven to breaking point on purpose. Although multiple

cracks may have been initiated, the stress was concentrated in one of the cracks, which has propagated through to the substrate. The weakest crack that propagated was off centre from the bending axis. Similarly, the chrome test specimens 1 and 2 had a single crack that propagated to the substrate off centre from the bending axis, but unlike the clad test specimens, no other significant cracks appeared in other areas of the surface.

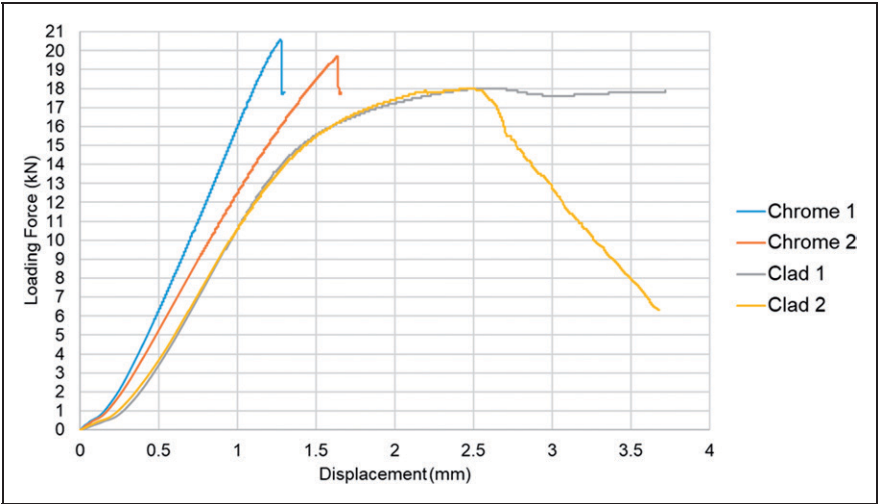
Figure 19. Loading Force vs Displacement for UTM testing.

Results of loading force versus displacement in the UTM are shown in Figure 19. The chrome test specimens have a higher breaking force and a steeper inclination, indicating that they are stiffer than the clad test specimens. The smooth change of the Clad 1 and 2 curves around 15 kN load, indicated that the material has started yielding due to the multiple cracks that appeared. Clad 1 has not fully fractured, while Clad 2 has fully fractured at 18 kN.

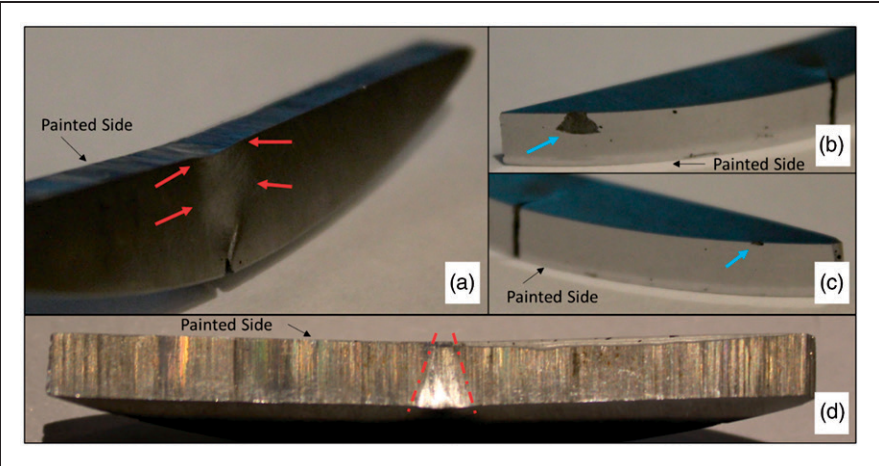
Figure 20. Chrome test specimen bulging out from contact with forming pin (a) chrome coating delamination at contact with fixed pins (b) and (c), uneven contact deformation from the forming pin (d).

Although initially the specimens were positioned “flat” on the UTM pins, during loading the contact stress, between the pins and the test specimens’ surfaces, was not uniform. The expected dent by the forming pin was not parallel, but conical, as shown in Figure 20(d). This was the case for all test specimens. This was due to the uneven contact stress, which was higher near the unpainted side of the test specimen, which was also bulging out the material as shown by red arrows in Figure 20(a). Uneven contact stress was also evident by the delamination of the chrome coating near the unpainted side and at positions that correlate to the fixed pin contact with the test specimen, examples shown in Figure 20(b) and Figure 20(c). The Ni-WC coating showed no evidence of delamination at contact with the fixed pins or elsewhere.

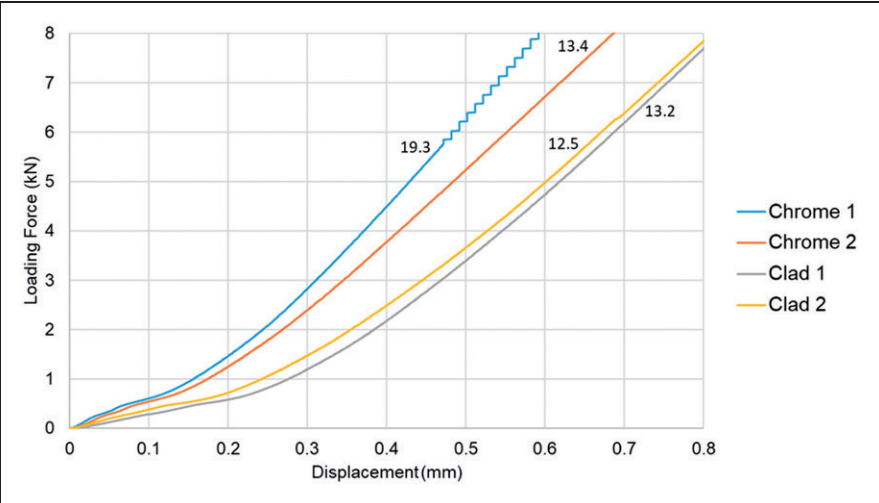
Figure 21. Loading Force vs Displacement early loading, slope gradient indicated on the graph for each test specimen.

UTM displacement measurements before yielding can be seen separately in Figure 21. The initial displacement over force is not linear, and the inclination varies until the equipment has settled. The clad test specimens exhibited the opposite behaviour in the UTM tests with lower stiffness than the chrome test

specimens. The chrome test specimens exhibited a wider spread in stiffness than the clad test specimens, this was evident in the UTM and SEM tests, as the clad test specimens in both tests showed similar stiffness gradients. However, due to the small number of samples used in the tests, it is not sufficient to make conclusions on the behaviour of the chrome test specimens. Considering that the clad coating is significantly larger than the chrome coating and the test specimens have the same overall dimensions, less substrate material remains in the clad test specimens after cladding. Reduced stiffness in the clad test specimen may be attributed to the reduced volume of substrate material and with the addition of a softer intermediate. It seems that loss of stiffness and higher ductility from the multi-layered clad test specimens seem resulted in a reduction of the linear portion of the curve, as well as earlier yielding. The strain hardening period from yielding to breaking is extended, allowing for longer displacement prior to full damage.

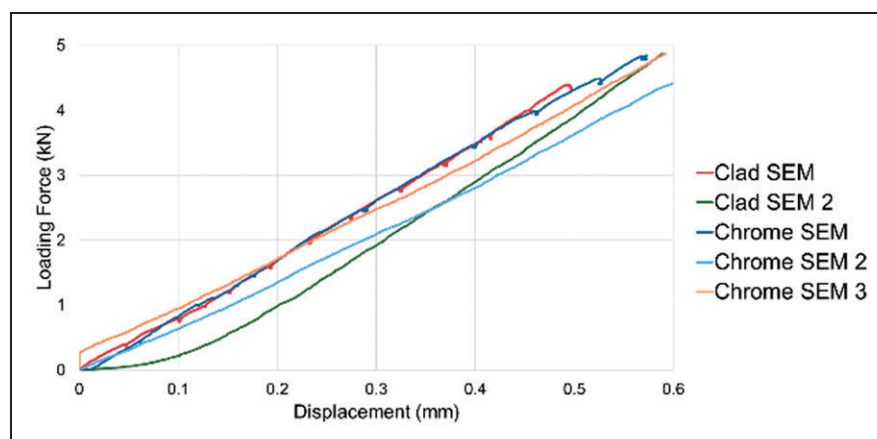
Figure 22. Loading Force vs Displacement for SEM tests.

The preliminary three-point bend test results from Camscan SEM are shown in Figure 22. The force/displacement curves from the SEM test are linear, except for Clad SEM 2 which exhibited significantly lower stiffness initially. The stiffness of Clad SEM 2 changed after 0.1 mm displacement to a slope similar to Clad SEM. This may be attributed to initial settlement of the specimen on the bending stage. Both Clad slope gradients are higher than the Chrome SEM test specimens' gradients, indicating they are stiffer. Chrome SEM and Chrome SEM 3 cross each other, indicating a wider spread in the Chrome test specimen stiffness'. Also, Chrome SEM 3 showed a sudden load increase at very low displacement, this might be due to an error in data transfer or load cell reading. Similar measurement issues that produced occasional oscillations on Clad SEM and Chrome SEM test specimens were attributed to the data transfer or the control system of the bending stage. Due to the linearity of the overall measurements, it was decided to include the results in Figure 22.

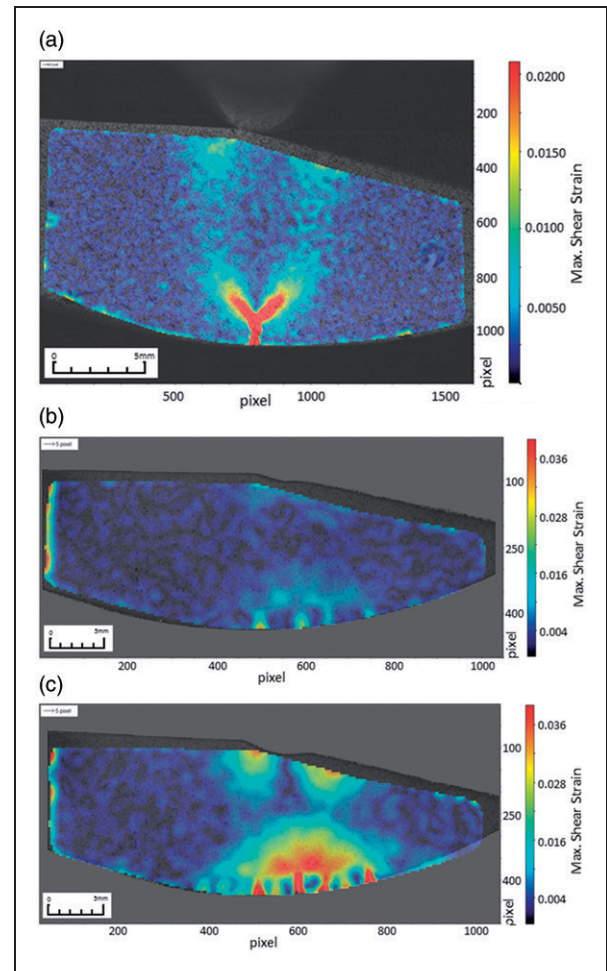
Figure 23. Maximum shear strain obtained from UTM Tests (a) chrome test specimen loaded up to 20 kN; (b) clad test specimen loaded up to 13 kN; (c) clad test specimen loaded up to 18 kN.

pattern was not as dense as in the other regions. Therefore, only results from UTM test specimens with a speckle pattern of black paint are presented here. Results from the chrome test specimen in Figure 23(a) indicate significant shearing values after the crack has appeared in the coating. The software analysis picked up shearing bands from the edge of the crack at 45° towards the substrate and 90° to each other. In Figure 23(a) shearing strain values of 0.015 have been shown to precede the cracks. These bands indicate that the crack may follow either direction and this is evident by the first two images in Figure 18 where the crack propagates into the substrate and changes direction by 45° . Strain analysis in Figure 23(b) was calculated from images is obtained by loading the clad test specimen from rest up to around 13 kN. High strain appears as expected and concentrated around a few cracks that opened up during loading. Above these cracks, a narrow shear strain band appears which correlates with the location of the intermediate clad layer. Analysis of the strain to a higher load of 18 kN in Figure 23(c) shows an increase in strain as expected, with values in the region of 0.038. Maximum shear strain values at 18 kN force are higher in the clad test specimen in comparison to values at 20 kN force for the chrome test specimen. Strain near the edges of the boundary may not be realistic and high strain calculation is not valid where cracks appeared since the speckle pattern is replaced by the cracks. The DIC was restricted to a particular area in the test specimen in order to exclude unwanted features such as shadows, for example in the top right section of the test specimen. Strain shown near the loading pin is due to the test specimen "folding" around the loading pin. As observed in Figure 20, the test specimen was plastically deformed by the loading pin, it is recommended on future tests to use a larger diameter loading pin, to distribute the contact stress and eliminate deformation from the loading pin. An interesting observation here is that the maximum shear strain away from the cracks is still concentrated around the intermediated layer and around the individual cracks, distributing the strain energy in a wider area by acting as a pivoting mechanism. This allows for a delay in crack propagation to the substrate. A less ductile intermediate layer or the lack of it may have resulted in behaviour similar to the chrome test specimen in Figure 23(a), whereby the strain energy is concentrated to a small region and crack propagation takes place earlier with respect to applied displacement.

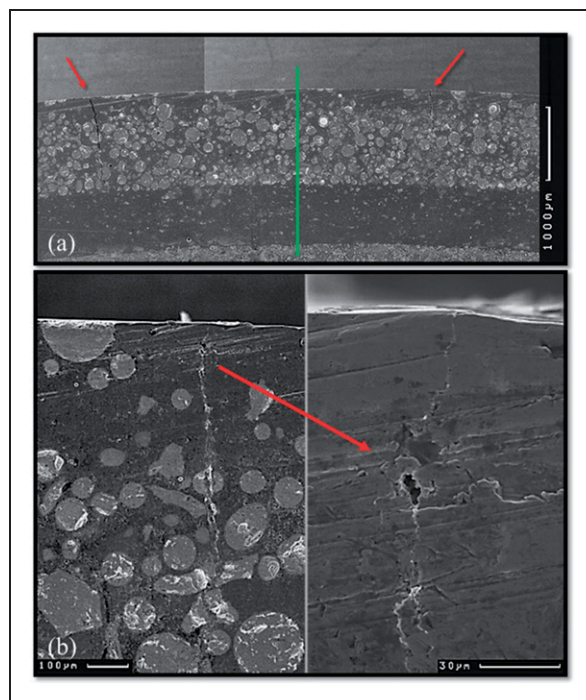
Figure 24. (a) Bending axis plane (green line) and cracks at either end (red arrows) for SEM clad test specimen; (b) Possible microstructure flaw or porosity that may have contributed to cracking.

Micro-cracks were present in both the clad and chrome test specimens. In both coatings, cracks appeared in multiple locations, more dominant in either side of the bending axis plane, which the plane formed by the bending axis and load path

vector (green line in Figure 24(a)). Cracks in the Ni-WC matrix coating have an origin from flaws in the microstructure and grow in multiple direction. This is evident in Figure 24(b). Due to the bending forces, the cracks were encouraged to grow towards the

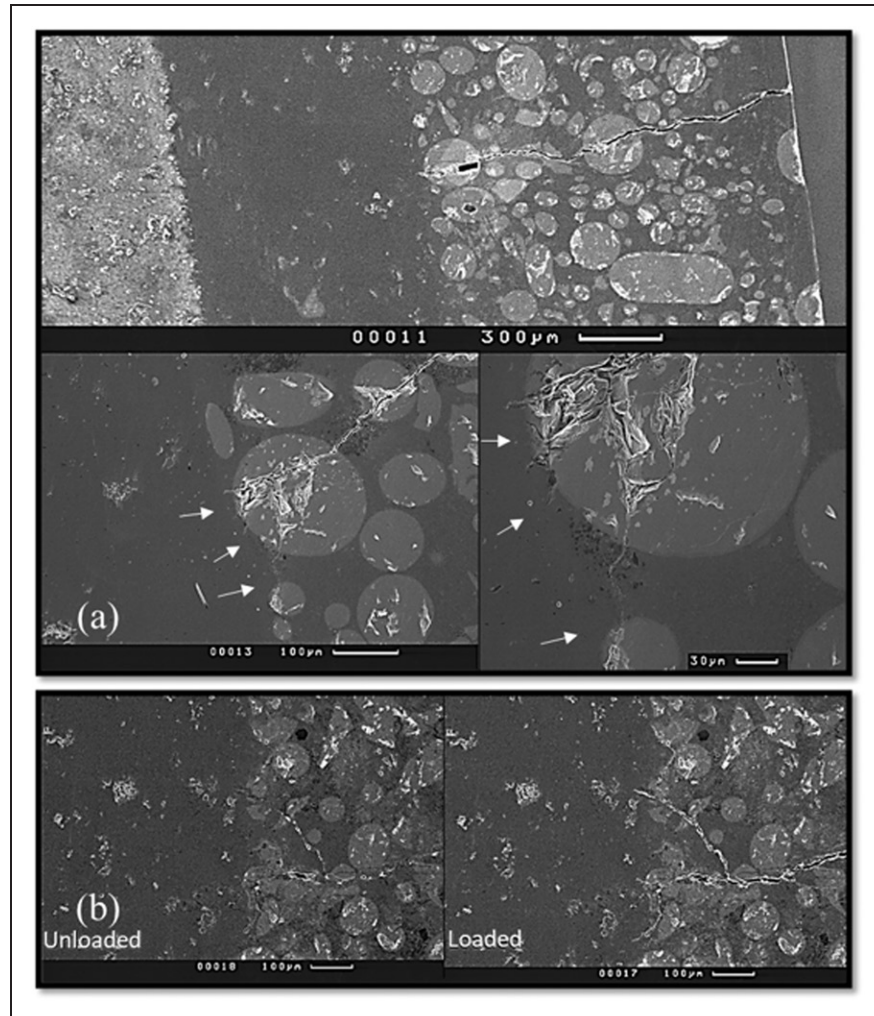
Figure 25. (a) Magnification on the crack end, indicating how cracks stop at the softer intermediate layer (white arrows); (b) Crack image with and without bending load.

substrate and it is clear that no cracks have propagated into the intermediate layer. Figure 25 is a good example showing the root of a crack in the Ni-WC coating leading to a WC particle, which branched out into multiple cracks out of the WC particle. The bottom right image of Figure 25(a) shows how a single crack trajectory has been influenced by WC particles and how the end of the crack has branched out into multiple cracks that have been directed towards the Inconel 625 layer and stop at the dilution zone. Figure 25(b) highlights the mechanism that characterises this behaviour. When the test specimen is loaded, the crack opens up by pivoting around the softer intermediate layer and because the intermediate layer is more ductile, it stretches to accommodate the bending forces and prevents the crack from propagating, as opposed to behaving in a brittle manner.

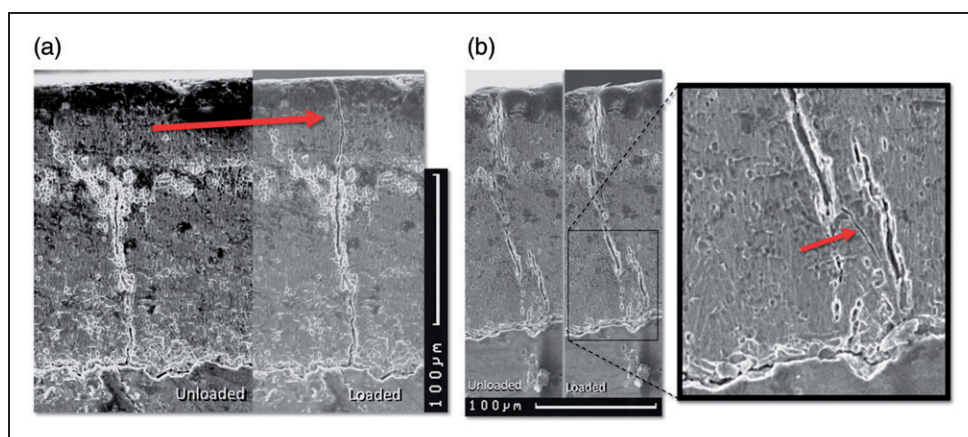
Figure 26. Cracks appearing on chrome test specimen after testing in the SEM.

The opposite occurred in the chrome layer, where cracks exist through the thickness of the coating and the bending load has either extended the cracks through the full thickness of the coating (Figure 26(a)) or generating smaller cracks which branched out to join other existing cracks (Figure 26(b)).
