and Wood, PJ (2021) Signal crayfish burrowing, bank retreat and sediment supply to rivers: a biophysical sediment budget. *Earth Surface Processes and Landforms*, 46 (4). pp. 837-852. ISSN 0197-9337

## RESEARCH ARTICLE

# Signal crayfish burrowing, bank retreat and sediment supply to rivers: A biophysical sediment budget

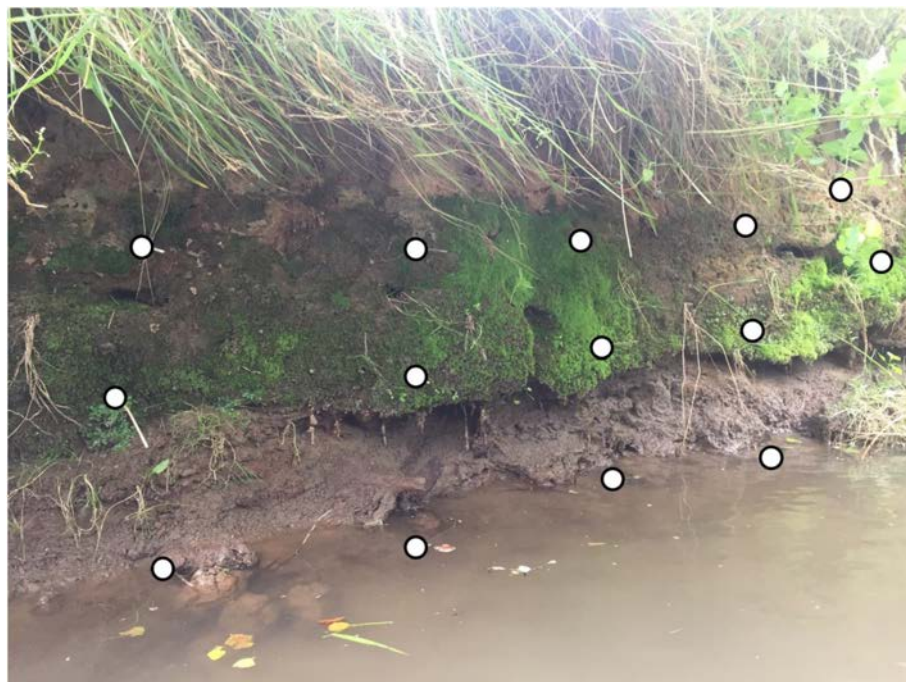
**FIGURE 5** An undercut bank on the River Bain. The spacing of the erosion pins (denoted by circles) was often too coarse to detect these local processes which lead to large-scale collapses. (NB: Photograph taken during low flow conditions for clarity of bank morphology) [Colour figure can be viewed at [wileyonlinelibrary.com](http://wileyonlinelibrary.com)]
