Cite this article: Mol L, Gomez-Heras M, Brassey C, Green O, Blenkinsop T. 2017 The benefit of a tough skin: bullet holes, weathering and the preservation of heritage. *R. Soc. open sci.* **4**: 160335. http://dx.doi.org/10.1098/rsos.160335

The benefit of a tough skin: bullet holes, weathering and the preservation of heritage

Lisa Mol^{1,2}, M. Gomez-Heras³, C. Brassey⁴, O. Green⁵ and T. Blenkinsop⁶

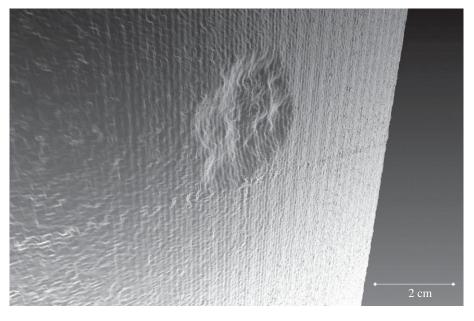
Figure 5. Mephisto Eos 3D scan of a bullet impact on the stone surface (not treated with Wacker OH 100).

Material loss from the surface after the bullet impact was almost negligible, as it averaged 2.57 g (0.05% of total weight) per sample (table 2), though loss of surface was clearly visible, as illustrated by figure 5. Interestingly, there was no noticeable difference reported between loss of mass from Wacker OH 100 treated surfaces and non-treated surfaces.

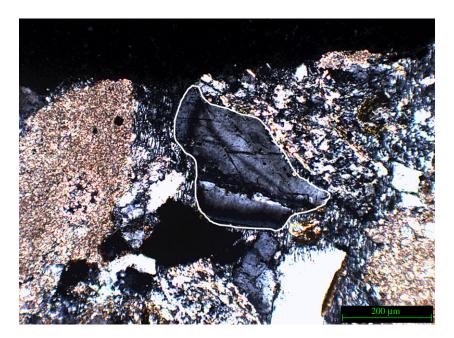
Figure 14. Sample 6 showing fractures, similar to those found in the non-consolidated samples. The mineral specifically referred to is outlined in white.

The above examples are observed in non-consolidated material. In consolidated material (samples 5–8) similar fractures were observed, implying that even though impact area development may differ the effects of the impact on mineral grains immediately surrounding the impact area are very similar. Figure 14 shows fractures found on the edge of the direct impact area in a Wacker OH 100 treated block (sample 6).
