Venkatesan, Senthil velan, Lim, Chan , Holdcroft, Steven and Kjeang, Erik (2016) Progression in the Morphology of Fuel Cell Membranes upon Conjoint Chemical and Mechanical Degradation. Journal of The Electrochemical Society, 163 (7). F637-F643. ISSN 0013-4651

Progression in the Morphology of Fuel Cell Membranes upon Conjoint Chemical and Mechanical Degradation

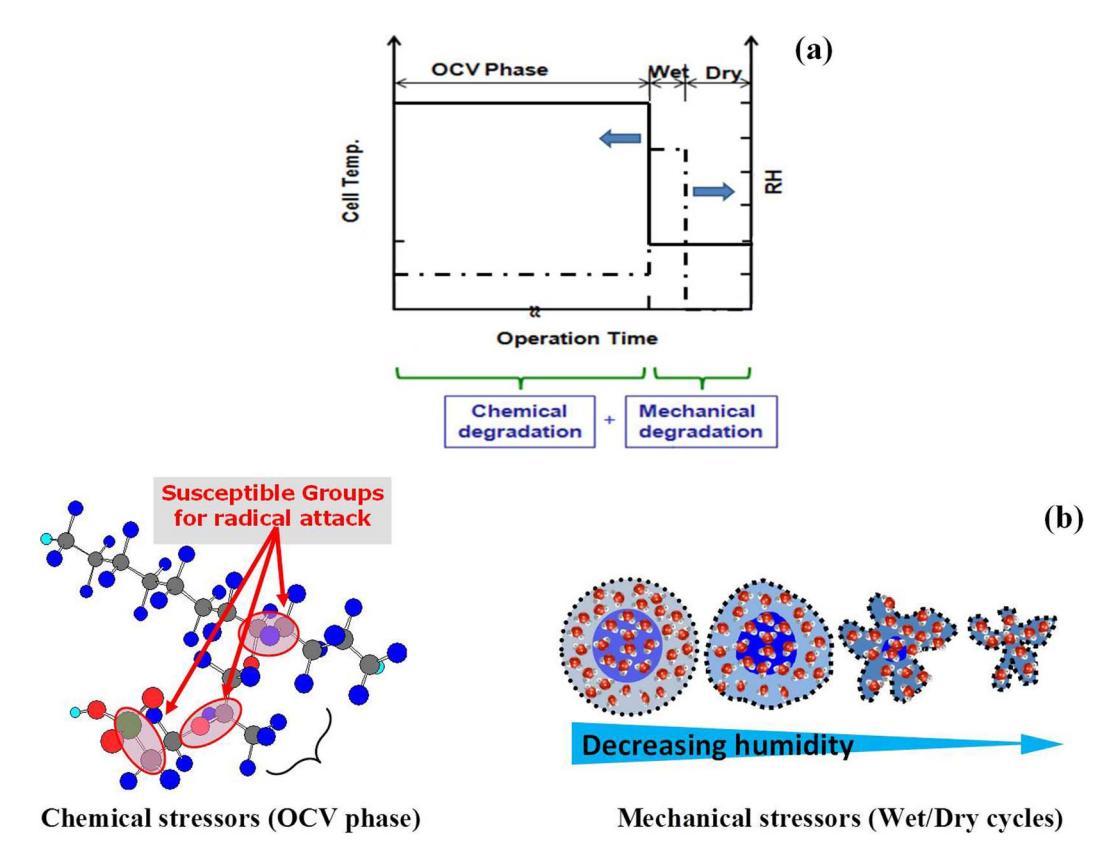
Figure 1. Graphical illustration of (a) the cyclic open circuit voltage accelerated stress test (COCV AST) and (b) its induced chemical and mechanical stressors on the membrane.

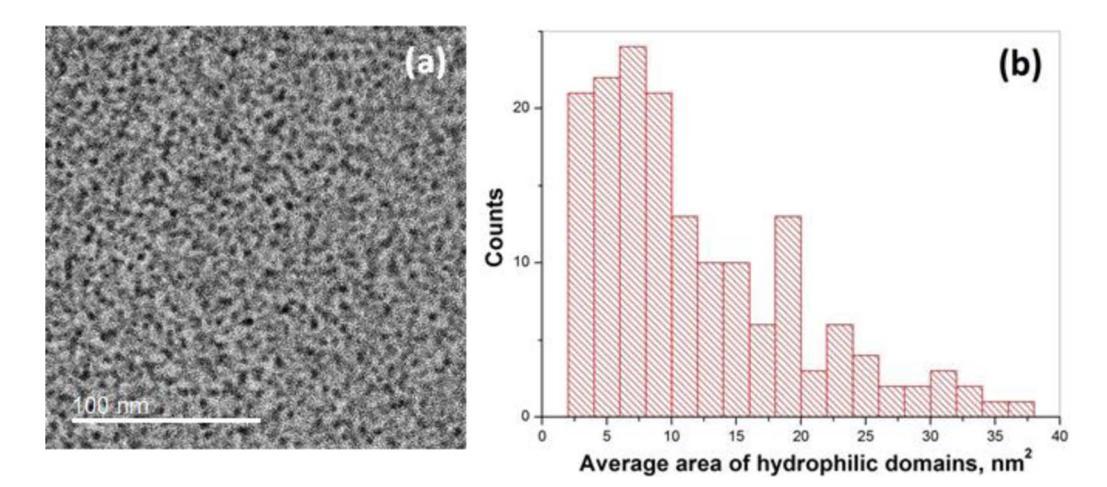
Figure 2. (a) TEM micrograph of a pristine PFSA membrane showing random distribution of dark ion-rich regions and bright tetrafluoroethylene regions and (b) statistical distribution of average hydrophilic (dark) domain area.

Micrographs of pristine and degraded membranes.—Figure 2a shows a representative bright field TEM micrograph obtained for the pristine PFSA ionomer membrane which features micro phase separated morphology of uniformly distributed ionic and non-ionic domains. Since the protonic sites in the membrane were exchanged with Pb²⁺ ions, the dark regions indicate ion-rich hydrophilic domains and the bright regions indicate non-ionic, hydrophobic fluorocarbon main chain domains. The ion-rich domains are randomly distributed in small pockets defined by the surrounding structural matrix of the fluorocarbon backbone phase. The statistical treatment of the image through the domain area distribution plot is presented in Figure 2b. Binary phase segmentation and domain area calculations were performed using ImageJ (with details provided in the Appendix) and the average hydrophilic domain area was found to be approximately 7.5 nm². The images obtained are in close agreement with previously reported images of similar membrane materials.^{7,23,24} Furthermore, the obtained absolute morphology result was reproducible on different pristine samples on different days using the same sample preparation and imaging techniques. It is thus expected that major alterations in morphology arising from degradation can be captured by this approach.

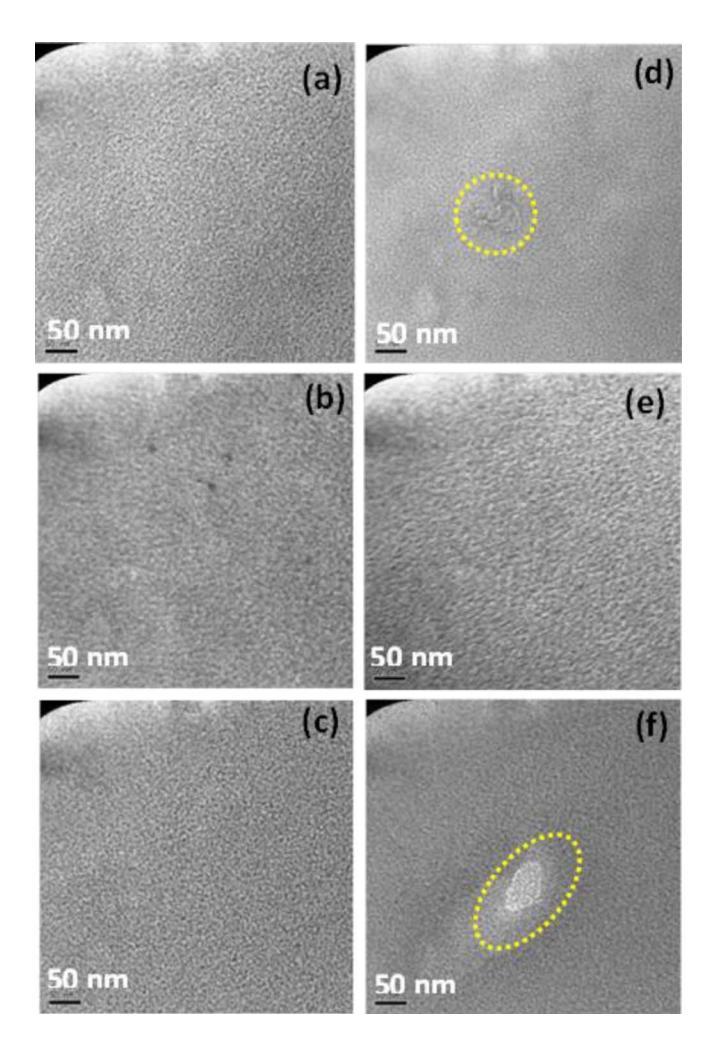
Figure 3. TEM micrographs of partially degraded membranes subjected to (a,d) two, (b,e) five, and (c,f) eight COCV AST cycles. (a-c) represent regions exhibiting regular ionomer morphology while (d-f) show specific features related to local degradation.

Figure 3 provides a collection of bright field TEM images observed for two typical regions of the partially degraded membranes from conjoint chemical and mechanical degradation using the COCV-AST protocol. Three different stages of degradation are shown (from top to bottom): two, five, and eight AST cycles. For reference, endof-life (EOL) failure was reached after ten AST cycles. The same sample preparation and imaging procedures, including Pb staining, were applied in all cases; hence, any change in the morphology compared to the pristine membrane (Figure 2) was due to the degradation

stressors rather than imaging artifacts. The two typical regions identified in Figure 3 represent regular morphology (a-c) present in the membranes after two, five, and eight AST cycles and special features related to local membrane degradation (d-f) after the same numbers of cycles. Notably, considerable variation in local morphology can be observed by comparing the images of the two regions. Though the regions exhibiting regular morphology were exposed to severe degradation stressors, the morphology of these regions were found to resemble the regular morphology of the pristine membrane, representing the bulk (overall) characteristics of the ionomer, whereas the regions exhibiting local degradation features were observed to deviate from the original membrane morphology, even at the early degradation stages. The extent of structural degradation as a result of radical attack and hygrothermal stress is expected to have perturbed the local morphology at the degraded sites. Apart from these special features observed due to local degradation, the images obtained after two and five AST cycles did not exhibit major morphological differences in other areas when compared to the pristine morphology. The relatively minor local degradation feature identified after two AST cycles shows a sudden disruption (encircled) in the phase-separated morphology that may have been initiated by locally elevated radical attack and resulting loss of functional groups associated with a local defect or contamination in the membrane or adjacent electrodes (Figure 3d). At this stage, however, the membrane largely appears

to withstand the effect of initial degradation. After five AST cycles, though most of the membrane area still exhibited regular morphology, a qualitative feature observed in some locations exhibits an increase in the ordering and long range formation of ion-rich domains, which differs from the pristine morphology. The long range ordering of ionic domains may be due to the permanent deformation and creep resulting from the induced mechanical stresses acting on chemically weakened ionomer domains (Figure 3e). Similar effects of polymer chain alignment along the direction of applied tensile force are a commonly observed phenomenon in the literature,²⁵ although it has not been previously shown for fuel cell membranes. At this stage of degradation, the membrane has already lost a substantial amount of fluoride from chemical degradation initiated from the side chains of the ionomer¹⁷ and hence affecting the functional groups, the loss of which is associated with decay in mechanical strength.¹² After a significant effect of degradation exerted upon the membrane through subsequent AST cycles, the radical attacked regions are believed to have lost a large portion of the sulfonic acid end groups, which can influence the local phase-separated ionomer structure. Interestingly, the membrane subjected to eight AST cycles revealed a relatively large non-ionic feature in the severely degraded region that resembles the presence of a hollow, void space in the membrane slice (Figure 3f). This is believed to be a result of more mature local degradation under the auspices of combined chemical and mechanical degradation,¹⁷ where the chemical degradation is expected to have propagated from the side chain onto the main chain of the ionomer (i.e., also affecting the hydrophobic backbone domain), hence enabling a longer range of local morphological changes in the ionomer structure. Such regions may ultimately lead to the formation of pinholes, which were previously observed to be ~100 μ m in diameter and occur at the frequency of five holes per 3 cm² survey area at the EOL state.¹⁷ However, the fine resolution of the present imaging technique is unable to resolve such 'large' scale features.

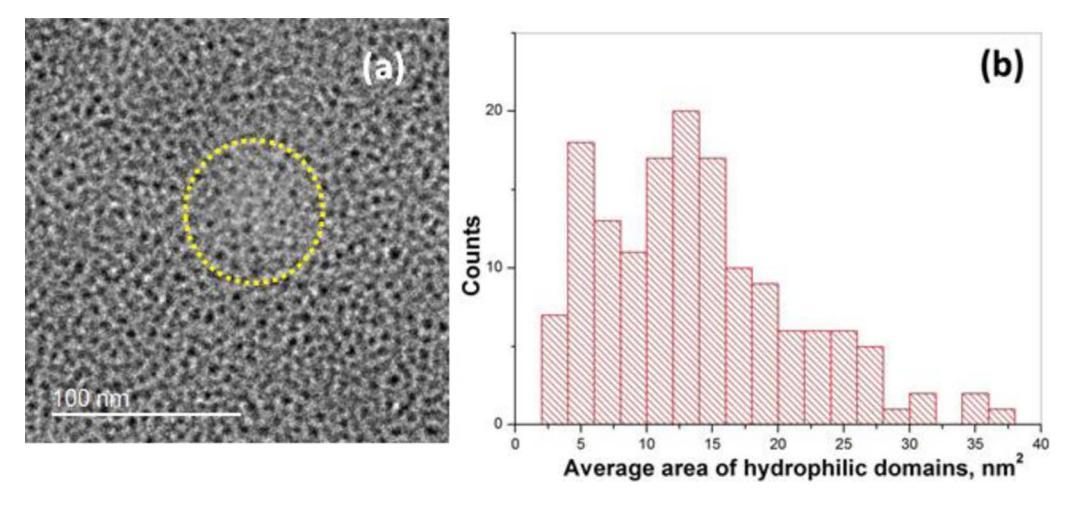
Figure 4. (a) TEM micrograph of the end-of-life membrane subjected to conjoint chemical and mechanical degradation. The encircled area indicates locally elevated chemical degradation. (b) Statistical distribution of the average hydrophilic (dark) domain area.

Figure 4a shows a bright field TEM micrograph of a typical membrane region at the EOL state. This image features regular ionomer morphology and a specific region (encircled) having reduced concentration of ion-rich domains essentially due to locally elevated chemical degradation. The morphology of the pristine membrane exhibited irregularly shaped ionic domains with low connectivity (Figure 2), whereas the morphology of the EOL membrane was found to have more spherical and highly networked ionic domains (Figure 4) which is believed to be an effect of bulk membrane degradation. These scenarios were observed irrespective of the imaging position across the membrane and are prevalent at the EOL stage. Statistical treatment was applied to the overall membrane structure, excluding the locally degraded zone in order to capture globally relevant effects. Figure 4b presents the obtained hydrophilic domain area distribution at endof-life. It was inferred from these data that the average size of the hydrophilic domain areas in the selected region had undergone an increment of ~16% compared to the pristine membrane. The calculated domain area distribution becomes bimodal at the EOL stage and a substantial increase in the number of domains in the range of 10-25 nm² was observed, in contrast to the smaller domain areas in the pristine ionomer. This was accompanied by a net increase in the hydrophilic domain fraction observed in the image from roughly 15% at BOL to 20% at EOL. These results suggest that the advanced stage of chemical degradation affecting both main and side chains of the ionomer (as evidenced by high fluoride release and membrane thinning) may have reduced the hydrophobic domain size, while the loss of sulfonic acid functional groups could lead to weaker local ionic interactions and hence an increased hydrophilic domain size. Thus, the overall collection of hydrophilic domains in the image appears larger compared to the pristine morphology. These results demonstrate the influence of global chemical degradation on the bulk membrane structure, in addition to the locally elevated degradation exhibited by the regions with special features. The findings are in agreement with previously reported ionomer mass normalized water uptake data, which indicated a sharp increase from eight AST cycles to EOL.²⁰ It is hence expected that the enlarged hydrophilic domains are filled with water during humidified conditions such as those prevalent during fuel cell operation.

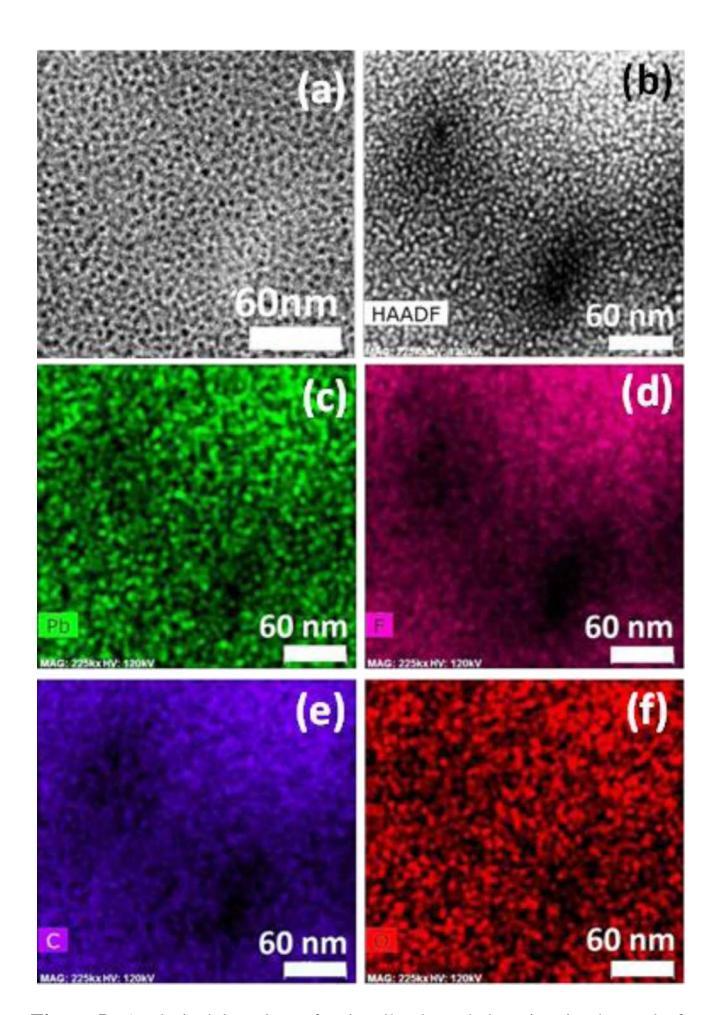
Figure 5. Analytical imaging of a locally degraded region in the end-oflife membrane: (a) regular TEM micrograph; (b) HAADF image; and (c-f) elemental maps of (c) lead, (d) fluorine, (e) carbon, and (f) oxygen.

main and side chains, chemical maps of these elements at the severely degraded site are also presented. Figure 5d indicates the absence of fluorine element due to severe fluoride release at the two hollow areas. The carbon map (Figure 5e) further reveals the loss of carbon to a similar extent in these two areas.¹⁷ The elemental map of oxygen presented in Figure 5f shows a similar trend of oxygen loss, albeit with

a lower contrast compared to carbon and fluorine in the local areas. The similarity of the oxygen and Pb patterns suggests a presence of residual water in the remaining hydrophilic domains, mainly located in the mildly degraded regions rather than at the hollow, severely degraded areas. The oxygen map could also potentially indicate the presence of terminal carboxylic acid groups appearing due to side chain degradation induced main chain cleavage at advanced stages of chemical degradation.^{10,11} Overall, the two hollow areas identified in these images are likely to have experienced an advanced stage of chemical degradation, involving both side chain and main chain decomposition, thus creating small essentially void features that may potentially grow further into macroscopic damage features such as micro-cracks and pinholes normally observed by SEM based failure analysis of EOL membranes.

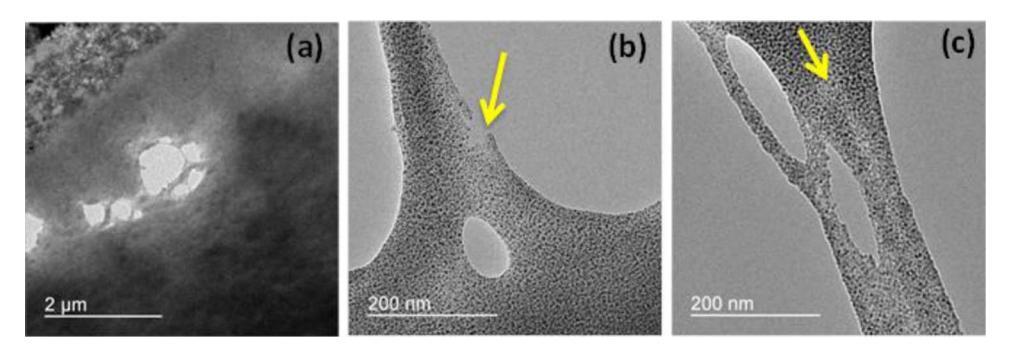
Figure 6. TEM micrograph of the end-of-life membrane showing (a) a local void site in the membrane, (b) a micro-crack initiation site in an ionomer fibril, and (c) local crack propagation along the low ion concentration direction (as indicated by the arrows).

radical attack at main chain sites is likely to increase over time. The gross loss of ionomer in the observed void areas is consistent with main chain, carboxylate-mediated degradation. Due to the 'hollow' nature of these chemically degraded areas, the local mechanical stress may be exacerbated around the perimeter of the site, thus further expanding the damage. Furthermore, chemical membrane degradation was previously found to increase the brittleness of the membrane during ex situ tensile testing,¹² which indicates that the chemically degraded structure is more susceptible to damage propagation under mechanical stress. It is noteworthy however that the macroscopic hydrogen leak carrying holes observed by SEM are essentially three orders of magnitude larger in scale than the hollow areas observed in the previous section, which warrants further analysis on damage propagation. Indeed, the present TEM analysis of the EOL membrane revealed a larger damage feature than those previously discussed, as shown in Figure 6a. This void feature is on the order of 1 µm in size, and is surrounded by several smaller hollow voids, which is indicative of local crazing around the edges. A magnified image captured from the edge of the void (Figure 6b) revealed a fibrillary ionomer structure which is most likely a result of mechanical stress applied to a chemically degraded area that stretches out the remaining ionomer strands during the process of damage growth. Another interesting observation from this image is the small micro-crack being initiated at the edge of the ionomer fibril at a specific site of low concentration of ionic clusters, which indicates that small cracks may propagate preferentially from chemically degraded regions (Figure 6b). The direction of crack propagation is also found to be along the direction of low concentration of ionic clusters, which is more distinctly shown in the supporting image in Figure 6c. These regions are likely to possess weak interaction between the constituent polar and non-polar phases due to chemical degradation and could favor mechanical fracture along this direction. In general, it is inferred that the mechanically yielding ionomer fibrils exhibit low concentration of hydrophilic domains. The severe side chain loss that caused a low concentration of ion-rich domains is likely to initiate the crack formation which is evident from the micrograph as shown by the arrows in Figure 6.

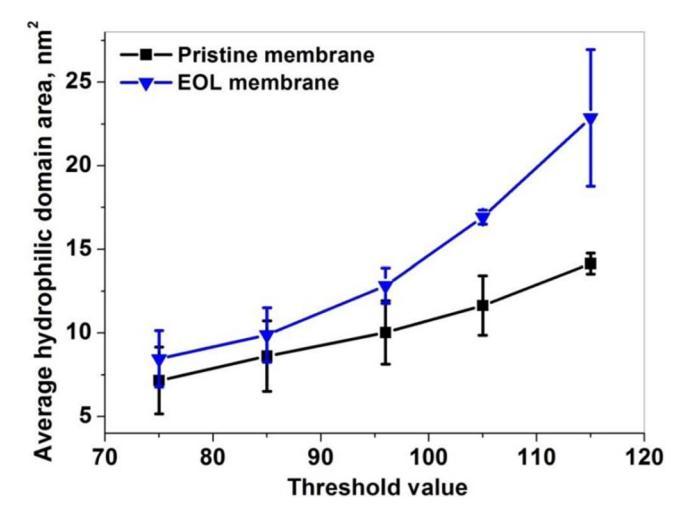
Figure A1. Sensitivity analysis carried out on the BOL and EOL membrane images for various threshold values.

interfaces. The BOL and EOL images were analyzed using ImageJ software for the average area of hydrophilic domains. The average domain area was calculated from the binary hydrophobic/hydrophilic images by assuming a threshold value for segmentation of the TEM images obtained at the BOL and EOL stages. From the sensitivity analysis, it was found that the threshold value is a sensitive parameter in calculating the average domain area. For any threshold value selected, the average domain area for the EOL membrane was always higher than at BOL, as shown in Figure A1. The threshold value set at 96 was empirically found to completely cover the hydrophilic area in the BOL membrane, and hence the same was selected for EOL membrane image analysis as well (Table A1). Two different regions of the same image were selected to carry out the domain area analysis. Domain areas from 3 nm^2 to 40 nm^2 were considered. This is based on previous reports on the size of hydrophilic domains considering circular cross sectional area.⁷ Hence, any domains less than 3 nm^2 could be due to image noise and domains above 40 nm^2 could be an artifact due to the application of thresholding, and the corresponding hydrophilic cluster diameter tends to be impractical.⁷
