# Investigation of 9000 hours multi-stress aging effects on High-Temperature Vulcanized Silicone Rubber with silica (nano/micro) filler hybrid composite insulator

# Abstract

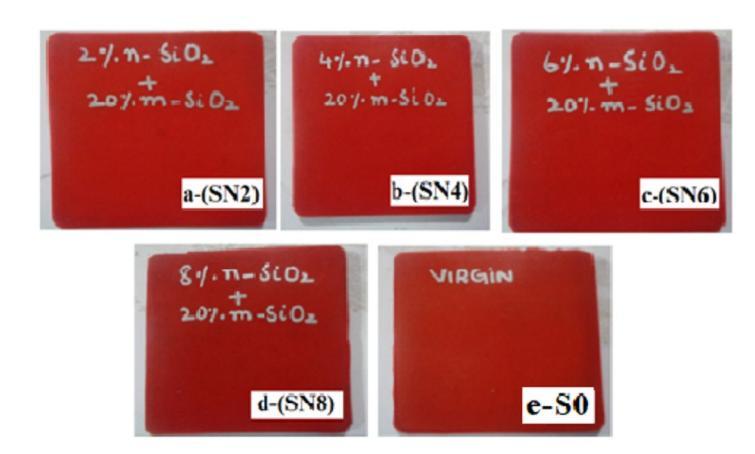
Fig 1. Original Samples, a- SN2, b-SN4, c-SN6, d-SN8 and e-S0. https://doi.org/10.1371/journal.pone.0253372.g001

Nano (size: 12 *n*m, density: 2.1 g/ $m^3$ ) and micro (size: 5  $\mu$ m, density: 2.52 g/ $m^3$ ) silica are acquired from Sigma Aldrich. All other chemicals used for the preparation process are of industrial grade. Methyl vinyl silicone rubber (colorless, molecular weight: 5800000, vinyl %:0.09, density: 2.54 g/ $cm^3$ ) is procured from DOW Corning, USA. Mixing and compounding method is used for the preparation of the sample. First of all, the fillers are suspended in 0.1 liter of ethanol. The mixture is stirred for 20 minutes. For preparation of the homogeneous mixture of filler in ethanol, ultrasonification is applied on the sample for 30 minutes. Silicone rubber is added in this solution under the process of sonication. For the removal of ethanol, the mixture is heated for an hour at 100°C. Later, it is placed in the mixture at 150 revolutions per minute (rpm) for 20 minutes at 150°C. This mixture is placed in pre-heated molds to get the required shape and size. The samples are cured at 170°C for 30 minutes. SiO<sub>2</sub> nanoparticles with varying percentages of 2%, 4%, 6%, 8% are added in the HTV-SiR base material, keeping the percentage of micro silica constant (20%). A neat sample (S0) is also prepared along with the hybrid samples. The composition of all the samples is shown in <u>Table 1</u>. Fig 1 presents the photographs of all the samples.

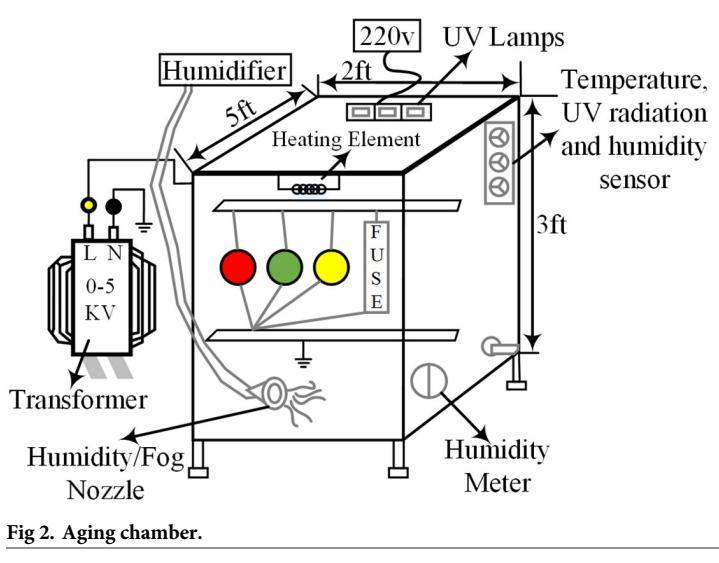
https://doi.org/10.1371/journal.pone.0253372.g002

Depending upon the stresses applied on the sample, a chamber is fabricated to stimulate the aging environment. A  $5ft \times 3ft \times 2ft$  plexiglass chamber is prepared as shown in Fig 2. The original picture of the aging chamber placed in the laboratory is shown in Fig 3. The samples are placed and stresses are applied simultaneously. A step up variac transformer of 220V/5kV is used to apply the electric stress. For the environmental stresses, UV radiations, heat, acid rain, fog, and humidity are applied. For UV radiation, three 20 watt UV lamps are installed in the chamber. 1000 Watt heater along with a controller is used to provide the desired amount of heat to the samples. For humidity, a humidity measuring element is used. The samples are placed in a chamber for 9000 hours. Summer and winter cycles are created and aged according to the conditions as shown in Table 2.

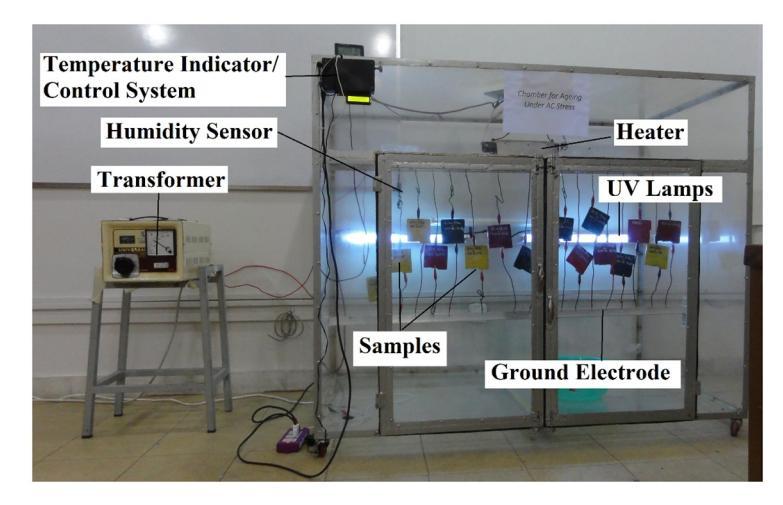
Fig 3. Real photograph of the aging chamber. https://doi.org/10.1371/journal.pone.0253372.g003

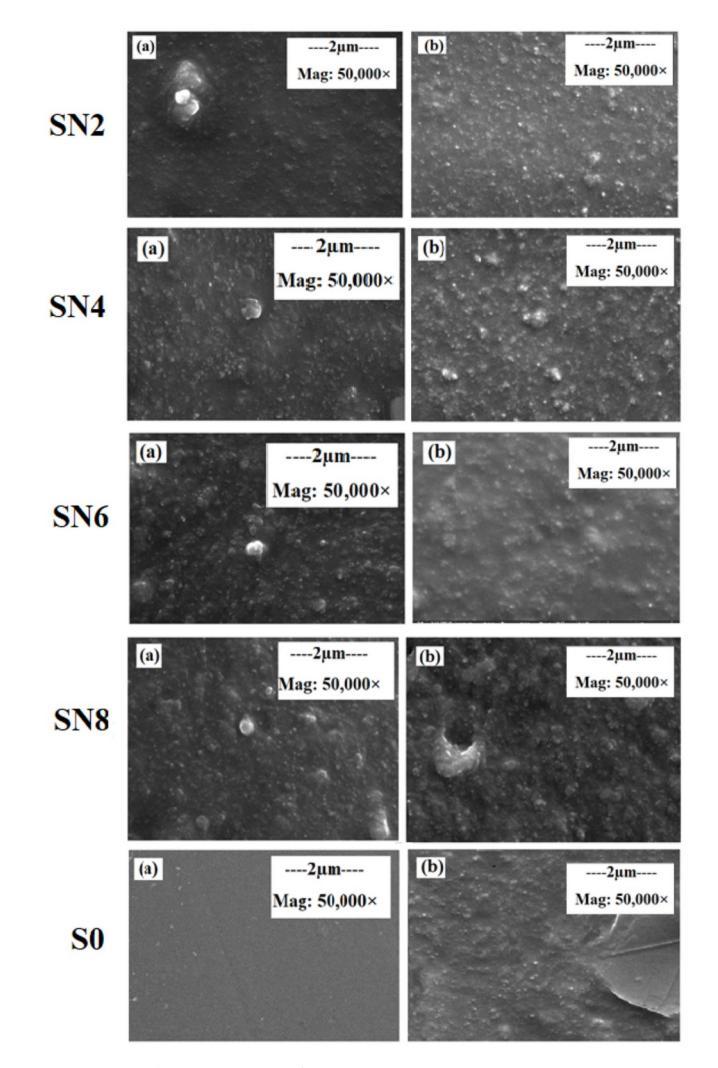
After aging, S0 has small cracks on the surface of the sample as compared to the hybrid samples. All the hybrid samples appeared to be less rough with less/no cracks on the surface. However, among all the hybrids, SN2 had higher surface intactness and less surface roughness as compared to the other hybrids. Therefore SN2 sample is less affected by the aging conditions. The main reason for better intactness of the surface in case of hybrid after 9000 hours of aging is due to the large surface area of nano-silica and the excessive presence of silonal group in case of the hybrids. So, the S0 sample without any nano-silica showed the highest degree of degradation when compared with the filled samples.

Fig 4. SEM a) Before aging, b) After aging of 9000 hours. https://doi.org/10.1371/journal.pone.0253372.g004

Scanning electron microscopy is performed to study the morphology of neat as well as hybrid samples. SEM analysis is conducted using field emission scanning electron microscope (FESEM, Hitachi U-5000, Japan). Fig 4 presents the SEM images for unaged and aged samples.

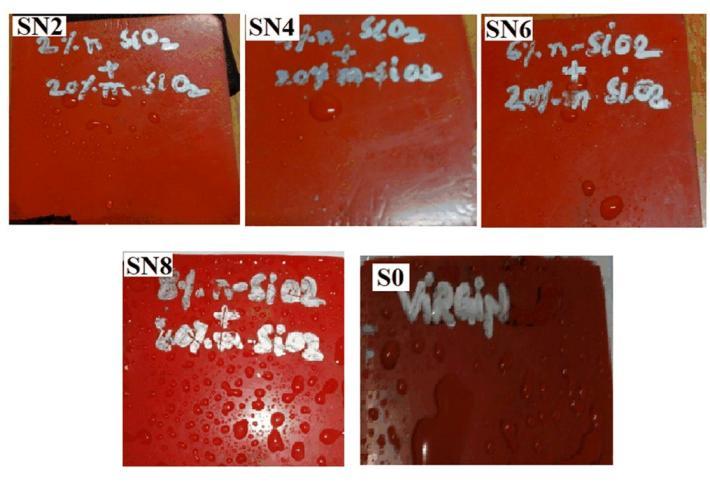
Fig 7. HC before aging. https://doi.org/10.1371/journal.pone.0253372.g007

chain to low weight molecules (LWMs). The deterioration of the insulation is caused by initiation of chain reaction forming stronger polar bonds, such as -OH, -C = O and C-O. These bonds start the molecular structure's cross linking, tree and pore formation. The reaction of the mechanism is given in Fig 6. The high HC level is due to the microscopic conductive paths. In [23, 24], the loss of hydrophobicity is due to the algae contamination. However, the recovery in the HC level is because of the movement of lower molecular chains to the surface. Figs 7 and 8 show HC before and after aging results.

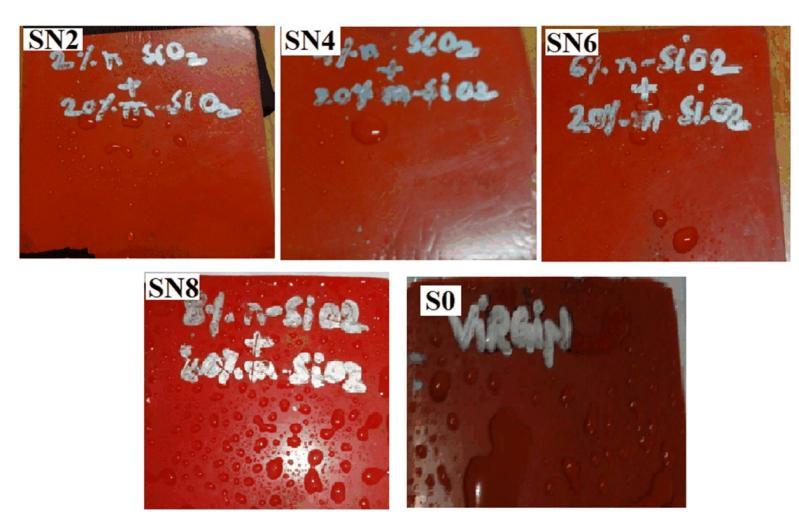
Fig 8. HC after 9000 hours of aging. https://doi.org/10.1371/journal.pone.0253372.g008

The recovery phenomenon is observed by all samples and it is the characteristic of a base material [23]. This recovery phenomenon is more pronounced in the hybrid samples as compared to S0. The main reason for the improved performance of hybrids (SN2, SN4, and SN6)

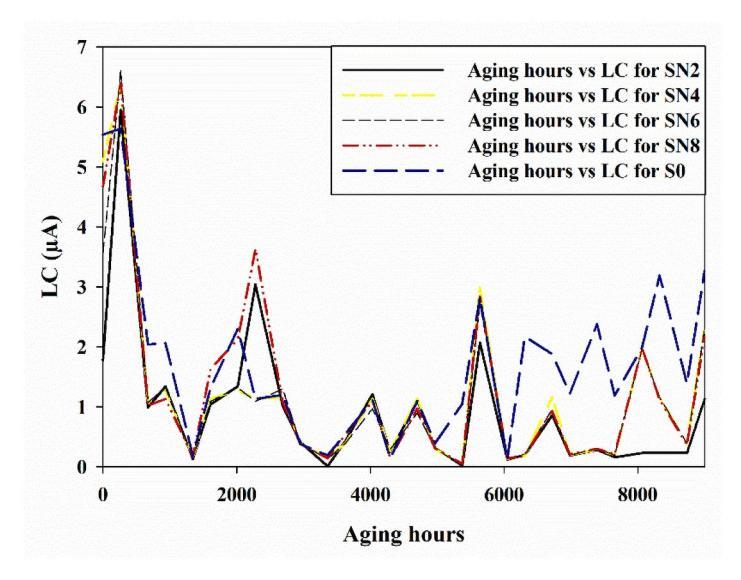
Fig 10. Leakage current aged from 0 hours-9000 hours.

The values are recorded at 40% humidity and 25°C as LC values are greatly affected by the variation in temperature and humidity [20]. The LC is presented in Fig 10 for every summer and winter cycle for the entire 9000 hours of aging.

Without stress application, the highest LC value of 5.54  $\mu$ A is calculated for S0 sample, whereas the lowest LC of 1.77  $\mu$ A is for the SN2 sample. As the aging started, an increase in the value of LC was observed for all the samples. The reason for this increase in LC is the relocation of the methyl group [16]. The highest value for the entire aging time of 9000 hours is measured at 264 hours of 6.6  $\mu$ A by the sample SN6. However, after the increase in LC, all the samples initiated to recover themselves. Our hybrid samples SN2, SN4, and SN6 have the lowest LC value as compared to the S0 sample throughout the artificial aging.

However, SN8 exhibited higher values as compared to the S0 sample. After 2000 hours of aging, again rise in LC is observed and then again recovery pattern is observed. Around 5500 hours, the rise in LC and after that recovery in the LC is measured. The recovery after 5500 hours is not as significant as it is after 2000 hours of aging. At the end of the aging, all the samples showed a trend in the increased values of LC values.

After aging, the highest LC of  $3.27 \ \mu$ A is exhibited by the S0 sample and the lowest LC of  $1.77 \ \mu$ A is exhibited by SN2 sample. Three hybrids SN2, SN4, and SN6 showed exclusively improved performance as compared to the S0 sample.

Overall, SN2 sample is the one with lowest LC values and thus less affected by the aging stresses. The main reason for increase in LC and less recovery is because of degradation in the polymer due to its exposure to the UV radiation. This phenomenon of the polymer degradation is also observed by other authors [26].

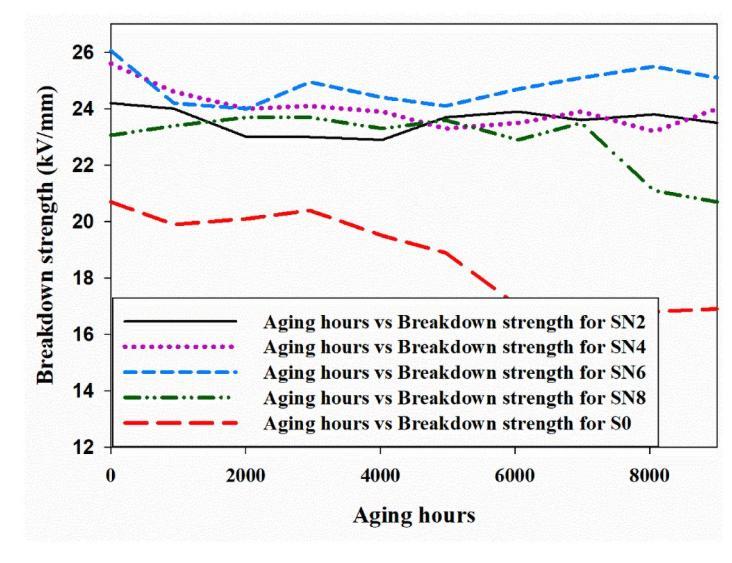
From Fig 11, it can be deduced that the highest breakdown value is measured for the SN6 sample whereas the lowest value is observed for S0 sample. S0 samples have the lowest breakdown strength for the entire 9000 hours of artificial aging. Breakdown strength is reduced after aging for all the hybrids. Between 2000 hours to 4000 hours, a similar trend in the values are observed for all the samples. After that, loss and gain recovery pattern is noticed for all the samples. SN6 sample started recovering itself after 6000 hours, whereas SN2, SN4, and SN8 again loss breakdown value around 6000 hours of aging. The lowest breakdown strength is exhibited by S0, thus making it the worst option among all the samples after aging. All the hybrid samples responded significantly to the multi stresses, whereas S0 sample is highly affected by the applied stresses. Among all the hybrid samples, SN8 is the one with the lowest breakdown strength value of 23.06 kV/mm. Still this value is higher as compared to the virgin sample. Overall, the hybrids have superior performance in breakdown strength after 9000 hours of aging.

The improved result in case of hybrid is due to the better cross-linking between the nano and micro filler with the base material. This addition of nano and micro filler provides the higher bond energy, homogenous structure, and less surface energy, which results in improved breakdown strength. It was observed that the addition of nano and micro filler improves the breakdown strength [27]. Similar behavior in the case of hybrid is noticed in our research.

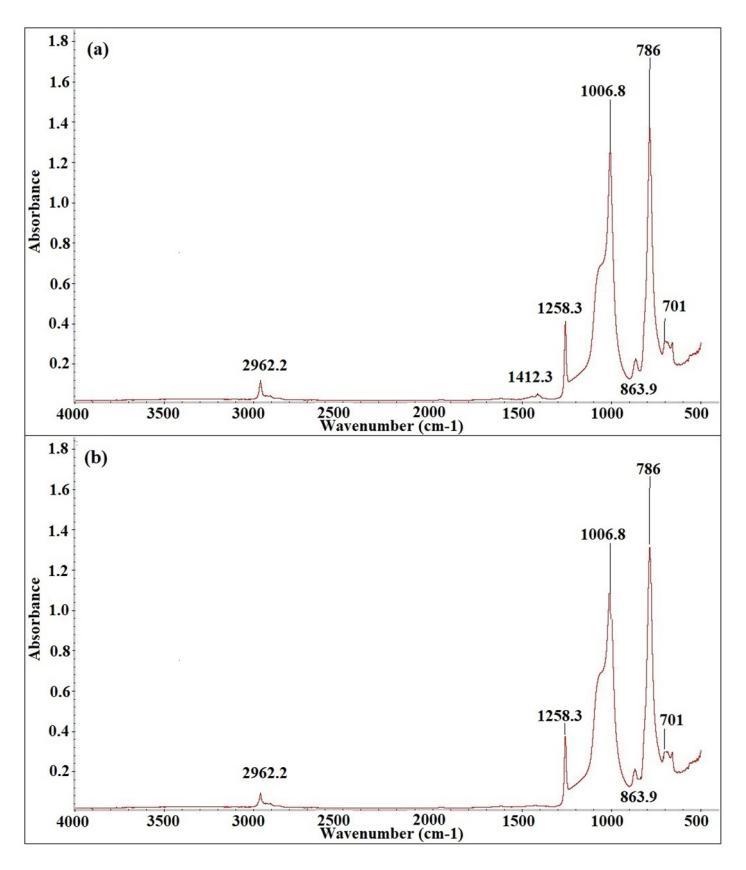
In Fig 12, the wavenumber and their respective absorbance peaks are shown for SN2. The certain absorbance peaks indicates the presence of important wavenumber numbers. The absorbance peaks are compared with the un-aged sample peaks throughout the aging time. Variation in the magnitude of the peaks show the degradation in the samples caused by the applied environmental stresses. From Fig 12, it can be observed that the wavenumber at 1440–1400 (cm-1) with bond CH<sub>3</sub> in Si-CH<sub>3</sub>, is the only one that loses itself completely at the end of the aging. The wavenumbers at 2963–2850, 1280–1240, 1130–1000, 840–790, and 870–850 (cm-1) with bonds C-H in CH<sub>3</sub>, Si-CH<sub>3</sub>, Si-O-Si, Si(CH<sub>3</sub>)<sub>2</sub>, Si-O in O-Si(CH<sub>3</sub>)<sub>3</sub>, and Si- of Si-(CH<sub>3</sub>)<sub>3</sub> lose 16.8%, 13.2%, 10.2%, 7.5%, and 5.14% at the end of 9000 hours of accelerated

Fig 12. Spectrograph for SN2 a) Before aging, b) After aging.

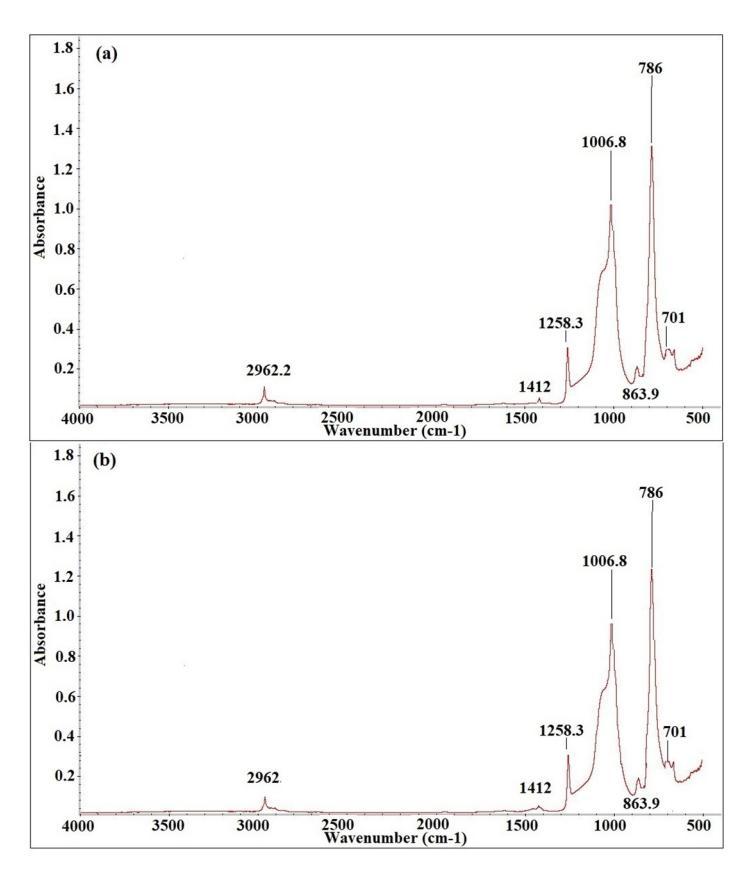
Fig 13. Spectrograph for SN4 a) Before aging, b) After aging.

In Fig 13, the spectrograph for SN4 with important wavenumber before and after aging can be observed. As the aging started, the sample started losing the intensity of certain peaks. At 936 hours, the percentage loss for wavenumbers 1258, 1008, 864, 786, and 700 (cm-1) for bond Si-CH<sub>3</sub>, Si-O-Si, Si(CH<sub>3</sub>)<sub>2</sub>, Si-O in O-Si(CH<sub>3</sub>)<sub>3</sub>, and Si- of Si-(CH<sub>3</sub>)<sub>3</sub> is 1.62%, 3.15%, 11.37%, 0.8%, and 3.125%. Thus the aging started to show its effect on the structures of the important wavenumbers. Overall, loss and recovery pattern is found in this sample. Later, a gain pattern is found after 8000 hours of aging till the end. After 9000 hours of aging, the bonds C-H in CH<sub>3</sub>, Si-O-Si, Si(CH<sub>3</sub>)<sub>2</sub>, Si-O in O-Si(CH<sub>3</sub>)<sub>3</sub>, and Si- of Si-(CH<sub>3</sub>)<sub>3</sub> have the percentage loss of 9%, 25%, 19%, 8, and 14%.

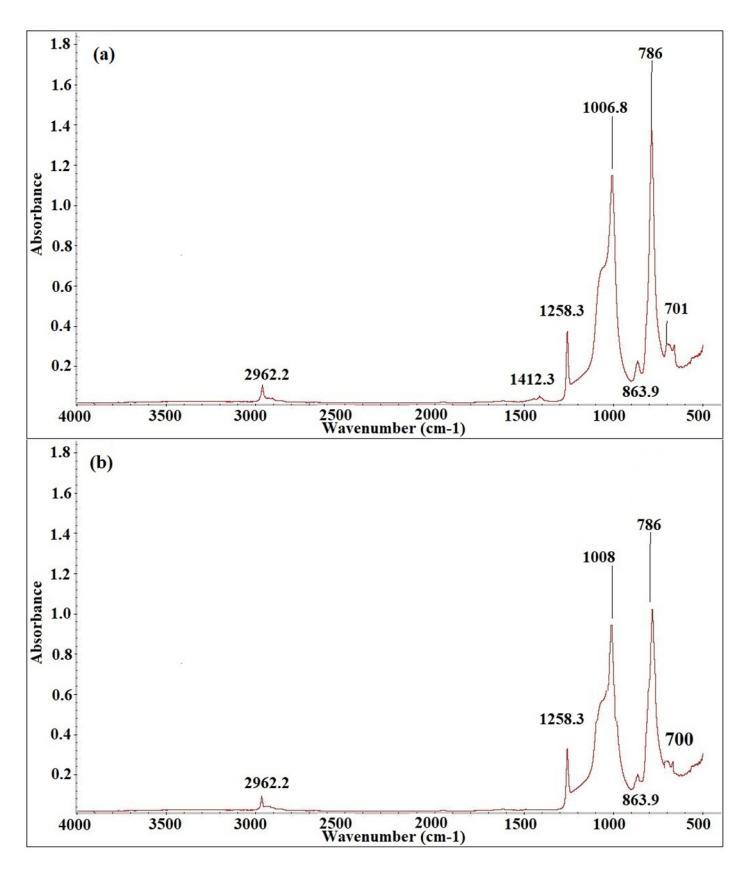
Fig 14 presents the variation pattern in wavenumber in spectrograph for SN6 before and after aging. Around 936 hours, the percentage loss by the bonds C-H in CH3, Si-CH<sub>3</sub>, Si-O-Si, Si(CH<sub>3</sub>)<sub>2</sub>, and Si-O in O-Si(CH<sub>3</sub>)<sub>3</sub> are 13%, 19%, 16%, 21%, and 9.5%. The sample shows an increasing tendency in the loss till 6000 hours of aging. After 6000 hours of aging recovery pattern is observed. The highest loss observed for the bonds are 34%, 36%, 22.8%, 22.1, and 28%. At 9000 hours of aging, the percentage loss is 31%, 37.55, 20.1%, 21%, and 26% for the wavenumbers C-H in CH<sub>3</sub>, Si-(CH<sub>3</sub>)<sub>2</sub>, Si-O-Si, Si(CH<sub>3</sub>)<sub>2</sub>, and Si-O in O-Si(CH<sub>3</sub>)<sub>3</sub>.

Fig 14. Spectrograph for SN6 a) Before aging, b) After aging.

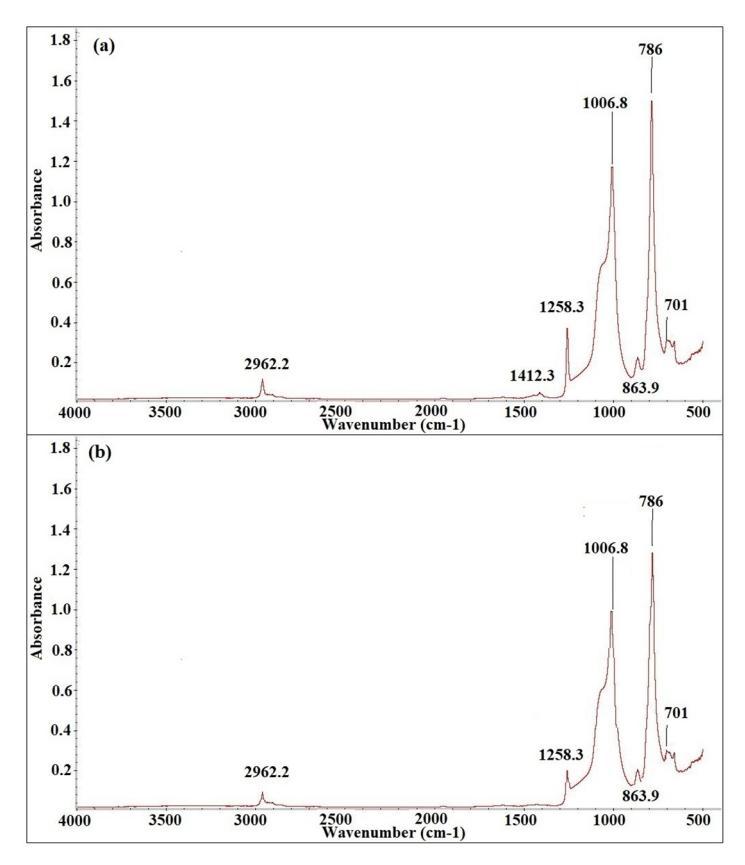
For SN8, Fig 15 represents the FTIR analysis graph. As the aging starts, the percentage loss around 936 hours is highest among all the hybrid samples. The bonds C-H in CH<sub>3</sub>, Si-CH<sub>3</sub>, Si-O-Si, Si(CH<sub>3</sub>)<sub>2</sub>, Si-O in O-Si(CH<sub>3</sub>)<sub>3</sub>, and Si-Si(CH<sub>3</sub>)<sub>3</sub> have the percentage loss of 16.66%, 25.6%, 48.16%, 33.33%, 32.66%, and 100%. The highest loss is observed around 6000 hours of aging for the same above bond number as 33%, 51.2%, 47.12%, 23.33%, and 100%. However, after 6100 hours of aging, the sample starts to recover itself and the percentage loss increases. Before 6000 hours of aging, the loss recovery pattern is observed but with small variation. However, the rise around 6000 hours of aging is significant. At the end of the aging, the samples have lower percentage loss for the bonds C-H in CH<sub>3</sub>, Si-O-Si, Si(CH<sub>3</sub>)<sub>2</sub>, Si-O in O-Si(CH<sub>3</sub>)<sub>3</sub> of 26.66%, 46.1%, 46%, 33%, 14%, and 33.33%.

Fig 15. Spectrograph for SN8 a) Before aging, b) After aging.

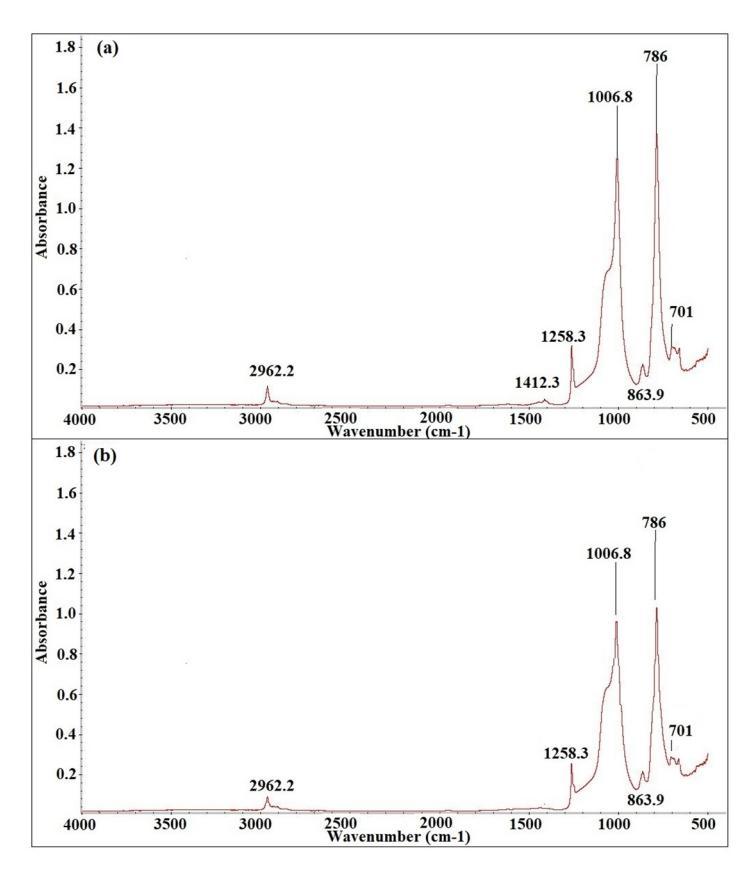
Before and after aging spectrograph for S0 sample is presented in Fig 16. For S0 sample, the loss recovery pattern is observed by all the absorbance peaks. However, the percentage loss for some of the peaks mentioned in Table 4 is highest as compared to the hybrid samples.  $CH_3$  bond in Si-CH<sub>3</sub> at the wavenumber 1440–1400 (cm-1), loses itself 100% and is unable to recover. Wavenumbers 1130–1000 (cm-1) for Si-O-Si bond, 840–790 (cm-1) for Si-(CH<sub>3</sub>)<sub>2</sub>, and 870–850 (cm-1) for Si-O bond in O-Si(CH<sub>3</sub>)<sub>3</sub> are the ones with percentage loss of 25% at the end of the experiment. Loss recovery pattern is observed for all the wavenumbers except 1440–1400 (cm-1). However, as compared to the other samples, this sample does not recover itself as much as the other hybrid samples do. It means this sample is highly affected by the weathering stresses applied on the samples. From The FTIR analysis for all the samples, we can conclude that the hybrid samples specially SN2 and SN4 are the ones with the lowest

Fig 16. Spectrograph for S0 a) Before aging, b) After aging.
