Whitehead, K, Pilkington, LI, Slate, AJ, Saubade, F, Amin, M, Lutey, A, Gemini, L, Kling, R and Romoli, L (2023) The cleanability of laser etched surfaces with repeated fouling using *Staphylococcus aureus* and milk. *Food and Bioproducts Processing*, 137. pp. 145-154. ISSN 0960-3085

# The cleanability of laser etched surfaces with repeated fouling using *Staphylococcus aureus* and milk

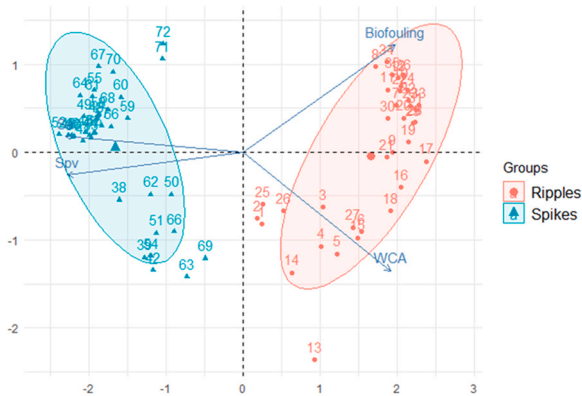
**Fig. 6 – PCA biplot visualising relationships between the surface roughness measures ( $S_a$ ,  $S_q$  and  $S_{pv}$  values), WCA and biofouling percentage for each of the surfaces and cleaning conditions. The 95% ellipsoids represent clusters based on surface texture type as the key variable with the following colours for each: spiked (blue) and rippled (red).**

When colouring each of the samples in the biplot by their texture (rippled or spiked) it was apparent that this was a critical feature in defining and characterising the surface, as demonstrated by the clear groupings and separated texture-defined clusters (Fig. 6, 95% confidence ellipsoids shown). Interpreting this result and the PCA, it was demonstrated that the spiked surfaces (blue) exhibited higher surface roughness measurements and had lower water contact angles and biofouling levels than the rippled surfaces (red).
